Operational causes of fatigue failures within passages of gas turbine engines

Zbigniew Korczewski, Assoc. Prof.
Gdansk University of Technology

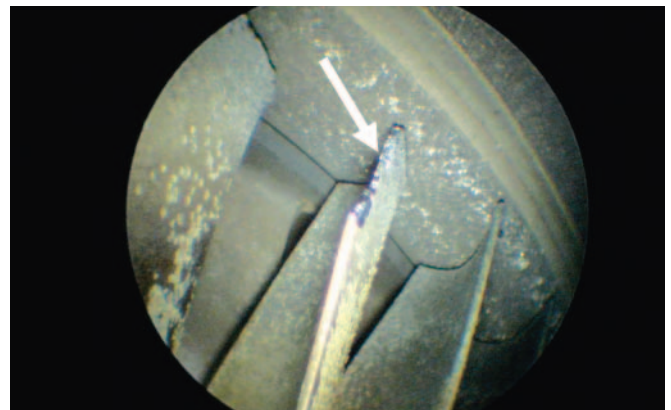
In extreme cases, local burning-of f edges and tips of HP turbine blades can happen, Fig. 2 and 3. Such failures of ship engine flow part usually result from sudden and unforeseeable operational events such as:

- choking the exhaust gas outflow due to fire in outlet channel,
- choking the engine air inlet (frozen air inflow shutters, sucking-in random things such as protective covers of shipboard devices etc).

Fig. 3. Burnt-off tips of HP turbine rotor blades (acc. endoscopic examination)

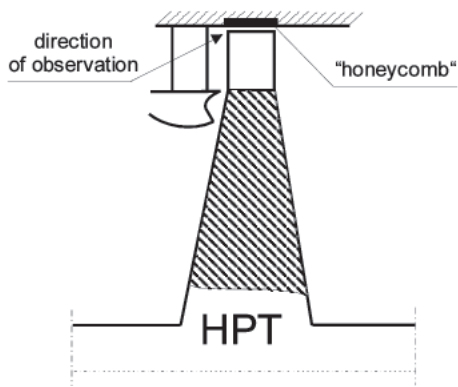
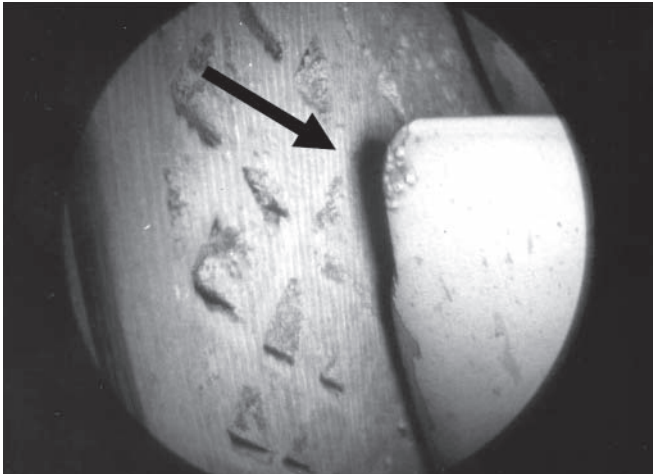
Fig. 5. Wear of sealing of HP turbine (HPT) rotor blades due to their seizing in engine body (acc. endoscopic examination)

It usually results in an intensive wear of body sealing of „honeycomb” type (Fig. 5), that in consequence leads to significant increasing the clearance of rotor blades of turbine and dropping its efficiency even by 10% [13]. It impairs efficient performance of entire engine because, as a result of increased radial clearance of HP turbine, character of distribution, to successive turbine stages, of disposed enthalpy drop becomes changed. The largest power drop occurs at the last turbine stages, i.e. engine propulsion turbine [12,13].

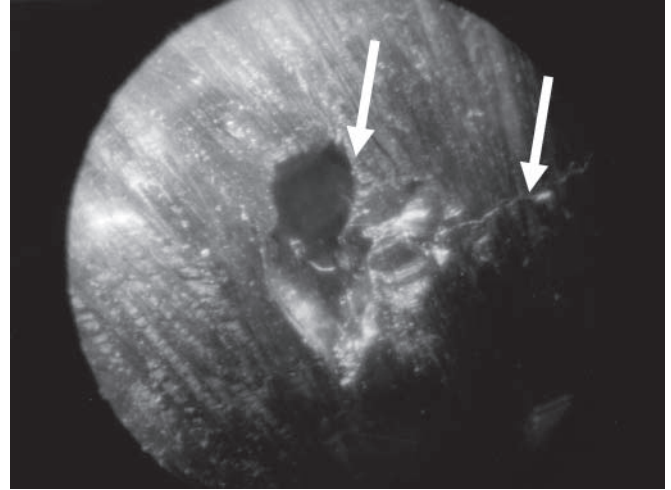
Another hazard to engine reliability, which results from rotor seizing in engine body, consists in possible cracking the compressor body, Fig. 6. The presented failure has been identified during endoscopic examination of a GTU6a single-shaft engine (of block structure) driving ship electric generating set. Compressor's body was made of 40HNMACr-Ni low-alloy steel of a higher metallurgical purity. The situation occurred as a result of immediate switching-off the engine from operation under nominal load and passing over the cooling phase under idle running. Such decision of operators resulted from a fire observed in exhaust gas channel and entering the engine into unsteady operation range. After that the engine was dismantled and sent to its producer Repair of the body consisted in vacuum electron-beam welding the crack.

On the basis of the character of the appeared failure of the compressor body it can be concluded that the initial cause of the crack was a material defect, e.g. presence of sulfides at place of fracture. In effect of action of dynamic loads the fatigue fracture propagating just from the edge of the material defect, was initiated. As a result of rotor seizing in the compressor body in the temperature of about 700-800 K, further propagation of the gap took place in the form of cleavage fracture. As the body was cooled more fast than the rotor the gap became separated mainly due to tensile forces (axial ones) with an influence of shear forces.

Designers of gas turbine engines take into account possible stopping the engine working under high load with passing over the cooling phase under idle-running. It is covered by manufacturer's testing program. Therefore the seizing of rotor units in engine body should not happen at all. However in the described case the engine immediate stopping was preceded by its unsteady work when a flash-back towards engine intake took place causing an inadmissible, very intensive rise of compressor material temperature much over its permissible value of 520K, determined by the manufacturer [15].

Fig. 6. Internal surface of GTU6a turbine engine compressor body, showing a fatigue fracture (acc. endoscopic examination)
