Current state of the waterway along the Warta and Noteć Rivers

Jan Kulczyk, Prof.
Radosław Werszko, D.Sc., Eng.
Wrocław University of Technology

In June 2004 took place an inspection trip aimed at assessing current state of the east-west waterway connecting the Odra and Wisła Rivers; during the trip a photographic documentation of the region was made as well. The below presented text contains also some conclusions resulting from the trip.

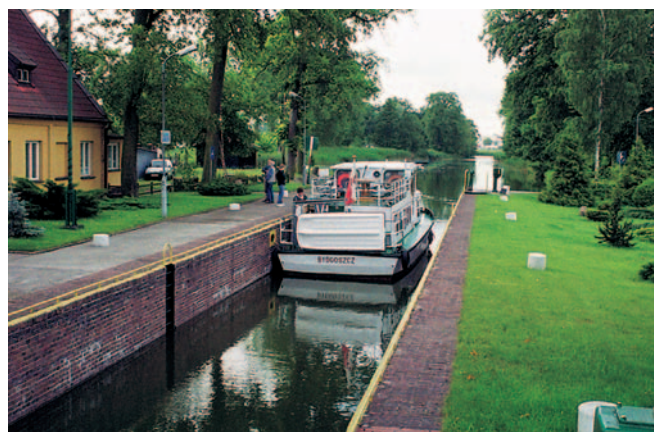
Currently all the sluices of the waterway in question and the weirs associated with them are serviceable and well maintained, however it mainly concerns the outer elements whose maintenance does not require any great financial outlays, whereas structural parts of some sluices have been found in a worse state. Families which operate particular sluices compete with each other in maintaining the area of their responsibility in the best appearance (Photo 1).

Photo 1. (J. Kulczyk, R. Werszko) Sluice no. 2 – Łabiszyn at the Upper Noteć, Headquarter of Waterway Supervision Office. At the sluice outer harbour an illuminated bivouac site with a bonfire place, tap water source, electric supply terminal and WC can be seen .

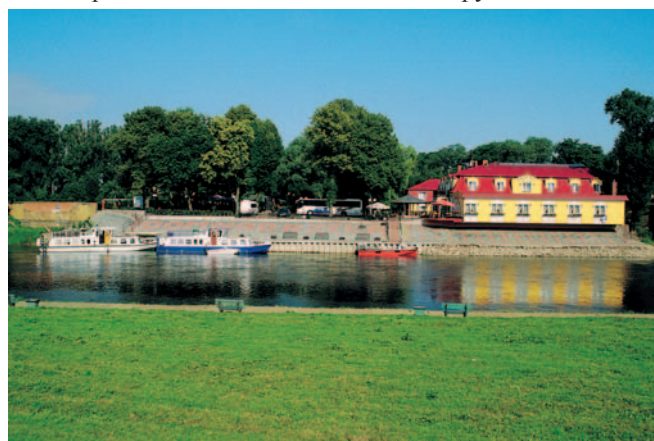
Photo 2. (J. Kulczyk, R. Werszko) The terminal in Skwierzyn upon the Warta, fitted with a tap water source, electric supply terminal, a nearby located hotel with restaurant and car parking place. On the opposite side a municipal promenade .

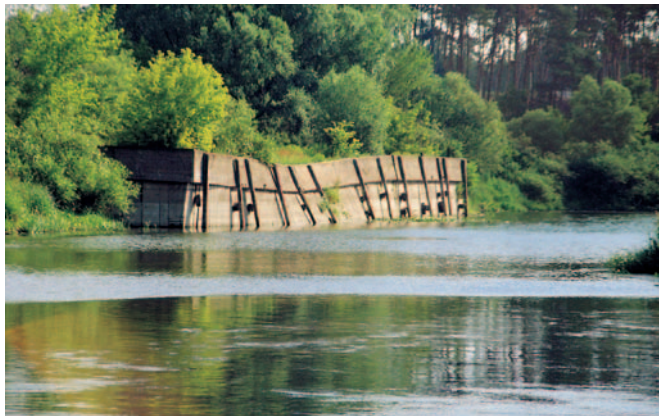
belonging to Bydgoszcz Shipping Company, or the winter stay for inland navigation barges at Krzyż. Many terminals are devastated, overgrown and deprived from mooring devices (Photo 3), and some of them should be presently deemed not existing at all. Harbour terrains in Poznań have been handed over for development of residential buildings, this way the city has been deprived from any possibility of receiving greater floating units. Moreover there is no real terminal equipped with any basic infrastructure.

Photo 3. (J. Kulczyk, R. Werszko) The devastated terminal in Oborniki upon the Warta .

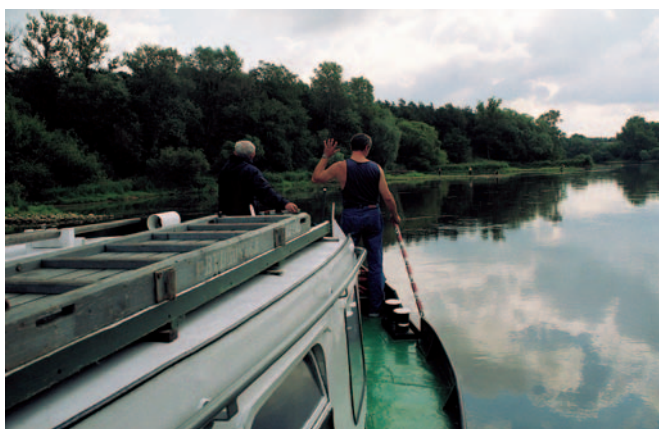
Almost all navigational obstacles are associated with a low water depth state (Photo 4). Lack of water in rivers, especially in summer, is associated with the general hydrological situation in this part of Europe, which today has a permanent character. This leads to appearing very shallow places which limit the passage depth for an entire waterway section even to 0.5 m that actually makes cargo shipping impossible and leaves the waterway useful to tourist shipping only. A section particularly shallow and difficult for navigation is the navigable part of the Upper Warta – beginning from the Prosna estuary to its inlet to the Ślesin Canal.

Photo 4. (J. Kulczyk, R. Werszko) A shoal patch of about 1-1.2 m water depth and many erratic boulders resting on the river bed section of some kilometers in length and located close to Puszczykowo upon the Warta. A crew member is heaving the lead and showing its result to the ship master .

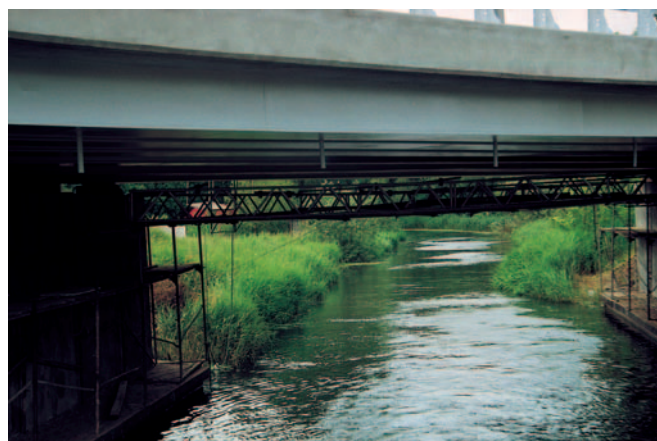
A next difficulty is the way of carrying out repairs of bridges and other structures in a direct vicinity of the waterway, namely without taking into account shipping traffic needs. During the inspection trip a repair of the road bridge over the Upper Noteć Canal, on the Bydgoszcz - Poznań route, has been carried out. The erected scaffoldings significantly limited the clearance under the bridge, which made it necessary to disassemble the ship’s signal devices and aials protruding over the wheelhouse deck of the ship. In the case of only a little higher water level, to pass under the bridge would not be possible at all.

Also, drainage pipes ranging by more than 0.5 m below the bottom of the bridge span may endanger ship safety. Repair work on other bridges in that region is carried out in a similar way and also similarly dangerous drainage pipes are installed there (Photo 5).

Photo 5. (J. Kulczyk, R. Werszko) A repair of the road bridge over the Upper Noteć Canal. The changes being introduced during the repair work are expected rather to remove the existing obstacles for ship traffic than to cause more troubles .

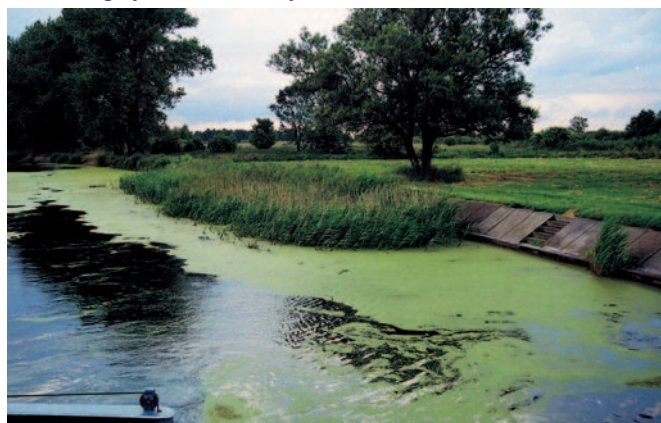
From the point of view of ship traffic an excessive quantity of plants overgrowing the waterway constitutes an obstacle (Photo 6). It causes disintegration and devastation of bank walls and water structures, an increase of ship resistance and it makes ship manoeuvring more difficult. Water plants, if wound around screw propeller, lead also to propulsion efficiency dropping and ship engine overloading, and clogging up the water inlet to cooling system, that may result in a serious failure.

Photo 6. (J. Kulczyk, R. Werszko) The overgrown outer harbour of Sluice no. 4 at Frydrychowo upon the Upper Noteć Canal .

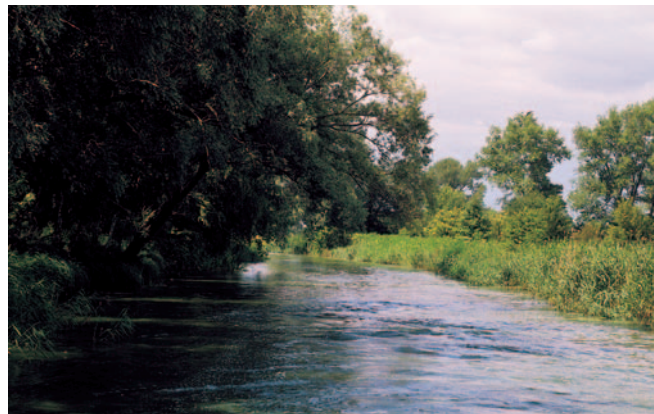
terway even by a half (Photo 7). Catching on tree branches generates a hazard for ship crews working on the deck; it may also cause a damage of protruding parts of the ship, e.g. signal devices or aerials. In consequence of scouring the trees growing at the river banks also their upsetting into the river may happen, that constitutes even a greater hazard – a failure to ship’s hull, rudder or propeller in the case of running onto an immersed trunk invisible. The upset trees may also cause a blockage of waterway for some time until the obstacle is removed.

Photo 7. (J. Kulczyk, R. Werszko) The crowns of the trees growing just on the river bank limit the waterway breadth in many places. Such waterway sections are attractive for tourists, but dangerous for ship traffic .
