Waterway of the Middle Vistula (Wisła) and the Bug

Piotr Kuźniar, D.Sc., Eng.
 Stanisław Pisarczyk, Prof.
 Eugeniusz Wilk, D.Sc., Eng.
 Institute of Water Supply and Water Engineering,
 Warsaw University of Technology

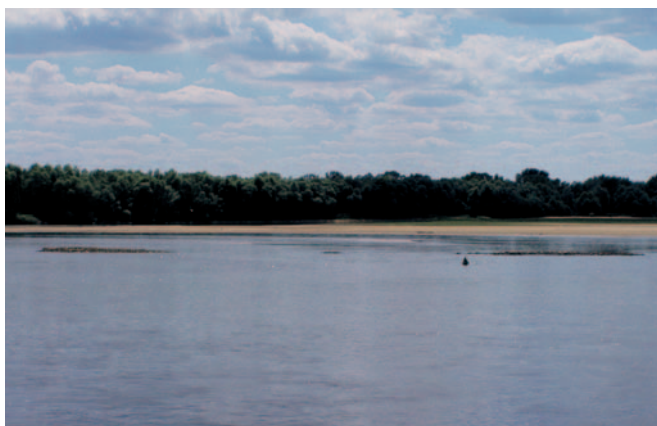
Lack of funds for systematic overhauls, lasting 25 years, has led to devastation of bodies of longitudinal protecting groynes and almost complete destruction of most transverse repelling spurs, from which only small fragments remained. The buildings are not capable of stabilizing the main-stream position and improving navigation conditions, sometimes in reverse – their rests located in the main-stream constitute a serious hazard to shipping (Fig.1). Changes of the main stream-way position happen after every larger freshet as well as ice run-off.

Fig. 1. Remainder of regulation infrastructure in the main stream-way of the Vistula (Wisła) .

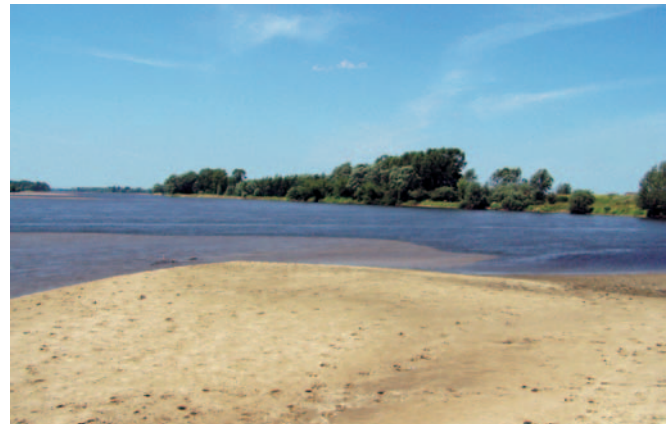
Then in the central part of the river-bed systematic accumulation of tracted rubble starts to occur, gradually covering larger and larger part of the width of the bed's cross-section and shifting the flowing water together with a part of the rubble material towards the banks. Along with water-level sloping larger and larger areas of low sandy islands emerge and narrow and deep beds similar to "chutes" appear close to the banks. In some cases water inflow to a "chute" occurs laterally to the bank (Fig.2).

Fig. 2. Lateral transition of the stream-way towards the river bank .

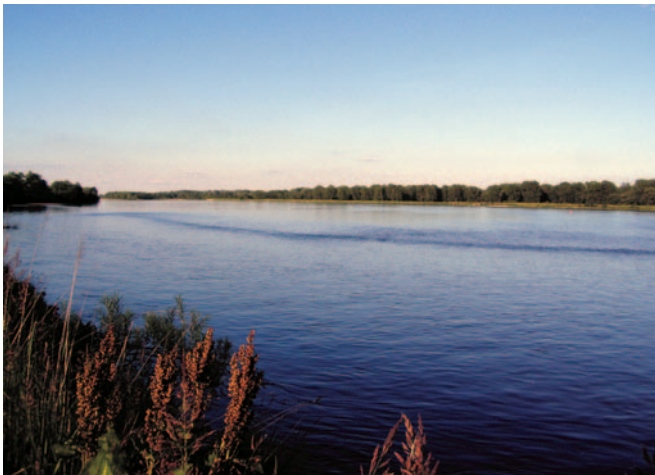
Fig. 3. The edge of the macro-fold along the firm river-bed section of the Vistula (Wisła).

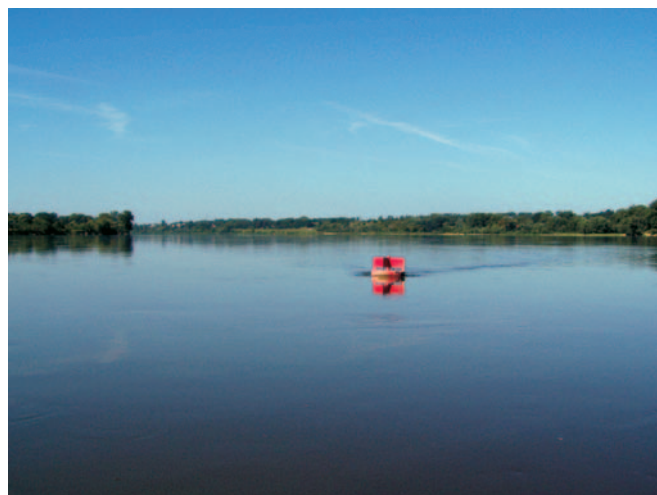
An important limitation for navigation on the Bug are curvature radiuses of the waterway. Taking into account the river bank curvatures one can expect the smallest radiuses to have about 100 m. On the bends of large curvatures the waterway width can be decreased – due to flow concentration – even to 15 ÷ 20 m (Fig.4). And, relatively favourable navigation conditions are observed along eroded banks. The stream –way is shifted towards the concave bank and only fallen-down trees can constitute an obstacle. In many cases the minimum width of the Bug waterway and its minimum radius can amount to a somewhat smaller values that those required by the rules.

Fig. 4. A typical course of the Bug river- bed .

Floating objects should then reduce its speed.

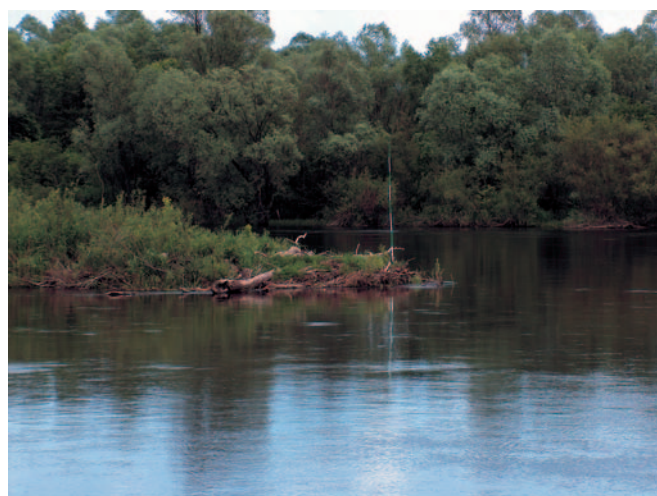
Though in the information materials [Informator 1961] the highest navigable water-level is given higher than the warning state, these authors have assumed that navigation will be continued only at the water-level contained within the river banks. Number of islands located in the main river-bed both of the Vistula and the Bug makes navigation at the higher water states more hazardous (Fig.5).

Fig. 5. Mark signing the cape of the island on the Bug waterway .
