ZBIGNIEW KORCZEWSKI, D.Sc., M.E.  
 Polish Naval Academy, Gdynia  
 Institute of Construction  
 and Propulsion of Vessels

# Endoscopic examination of naval gas turbines

The paper presents application of endoscopy in diagnosing the naval gas turbines. Selected results of such examinations with the use of fiberoscopes, carried out on the turbines installed on the Polish Navy vessels are included.

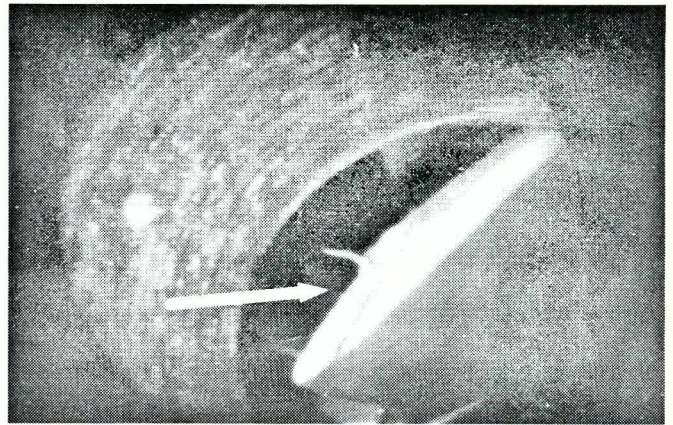
Fig.8. The 1<sup>st</sup> stage rotor blade of HPC of DE59 engine. Jamming traces on the blade tip edge

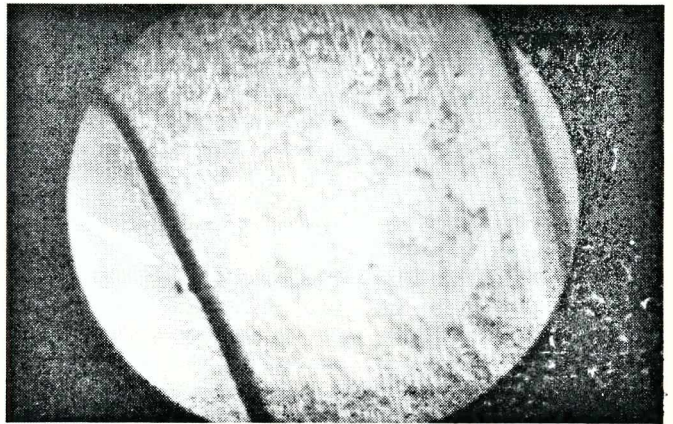
Fig.9. The rotor blade of HPT of DR77 engine. Partly burnt and chipped tip edge

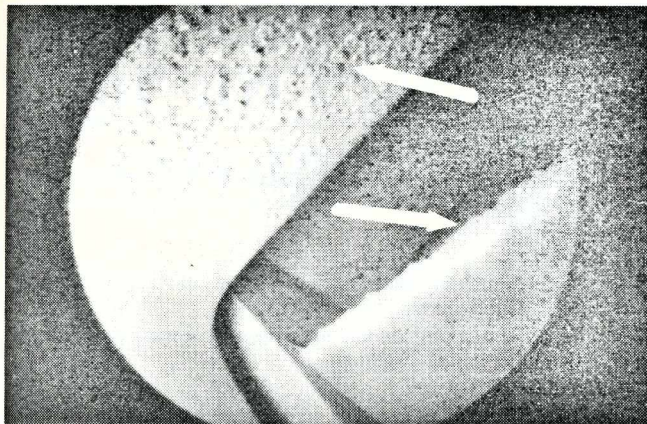
Fig.6. The 1<sup>st</sup> stage fixed and rotor blades of LPC of DR77 engine. Fouling deposits on the blades' surfaces

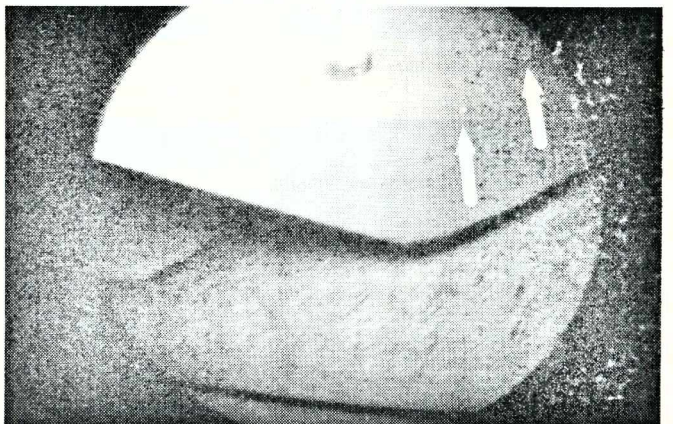
Fig.10. The rotor blade of HPT of DR77 engine. Surface bulges („blisters”) at the blade back plane

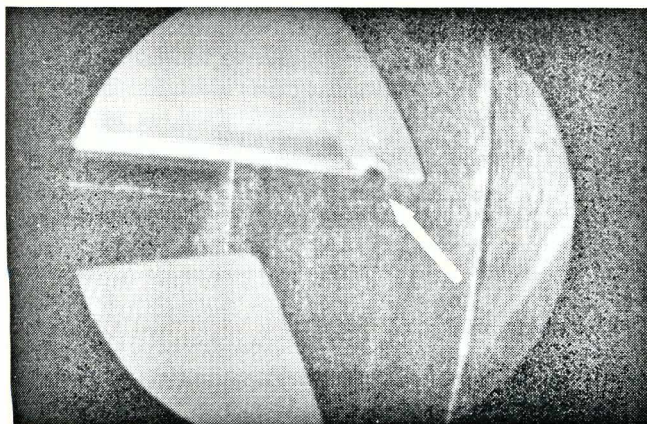
Fig.7. The 1<sup>st</sup> stage rotor blade of HPC of DR76 engine. A dent on the edge of attack, close to the blade tip

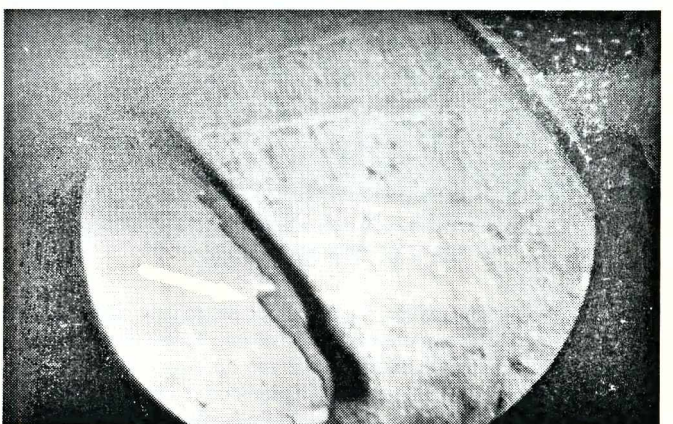
Fig.11. The rotor blade of HPT of DR77 engine. Damage (cavities) of protection coating at the blade tip edge

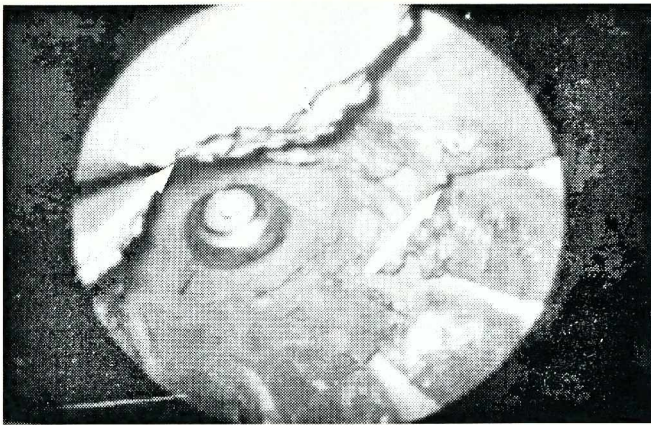
Fig.12. The fire pipe of CC of DE59 engine.  
Carbon deposit layer on the swirler blades

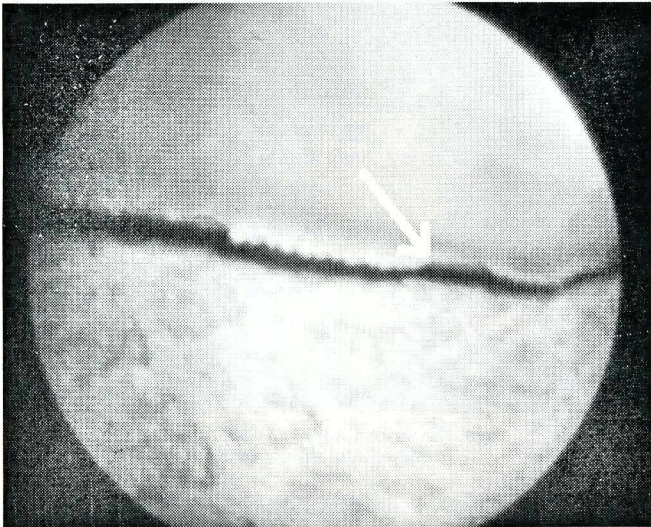
Fig.13. The rotor blade trailing edge of HPT of DR77 engine.  
Fouled cooling ducts

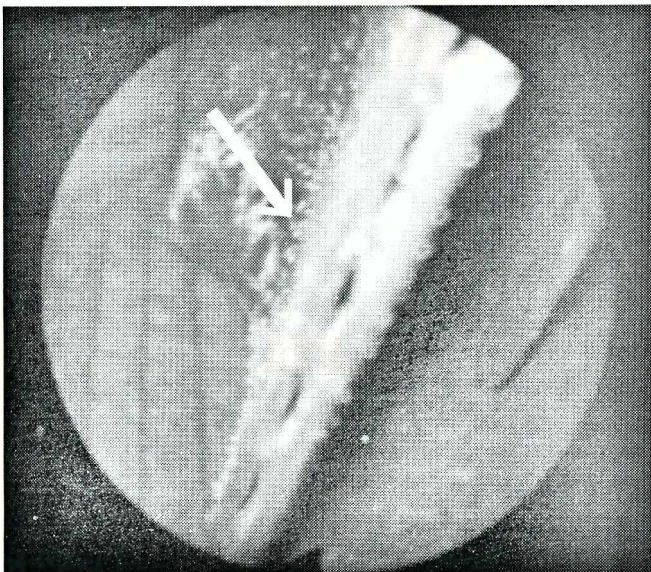
Fig.14. Enlarged tip clearance of the rotor blade of HPT of DR77 engine  
with visible traces of jamming in turbine casing
