EXPERIMENTAL RESEARCH ON INSUFFICIENT WATER LUBRICATION OF MARINE STERN TUBE JOURNAL BEARING WITH ELASTIC POLYMER BUSH

Agnieszka Barszczewska
Gdańsk University of Technology, Poland

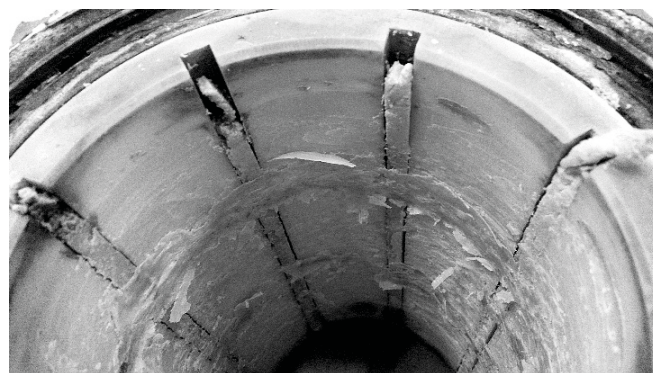
Fig. 1. Elastomer bush melted during the laboratory test. Test conditions: load: 0.2 MPa, speed 10 rev/s, water flow 0 L/min.

The tested bearing was able to work properly for established time at marginal water flows, but probably not without any wear. Both tested bushes had undergone melting and hydrolysis (Fig. 1). The deep cracks in the sliding surface, characteristic of the hydrolysis process, indicates that the bushes had been subjected to the long-term exposure to water at a temperature of at least 50°C. Thus, the process of hydrolytic degradation of the bushes could have already occurred during tests at the water flows greater than 0 L/min.

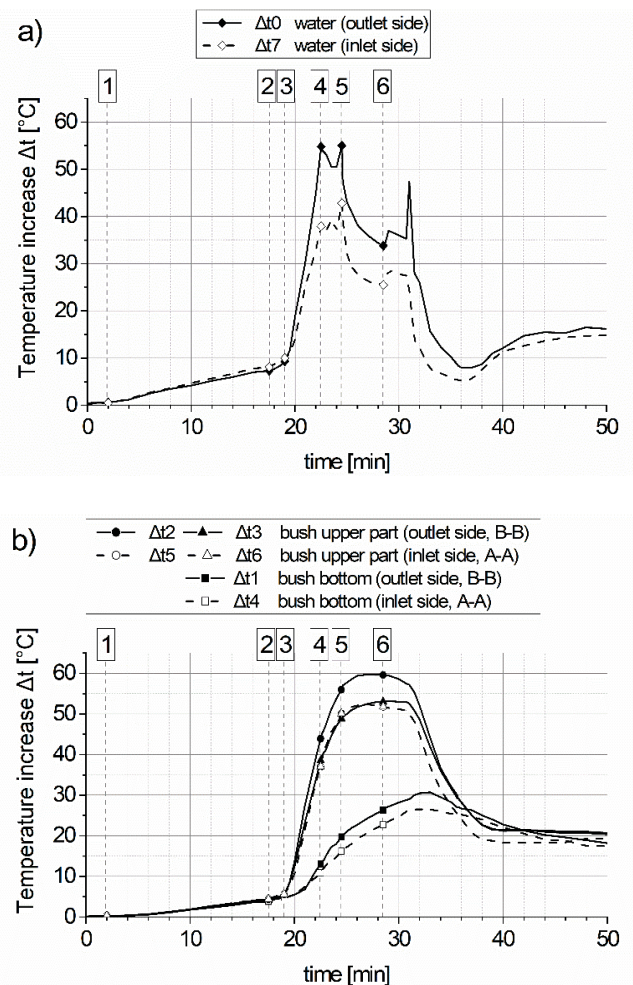
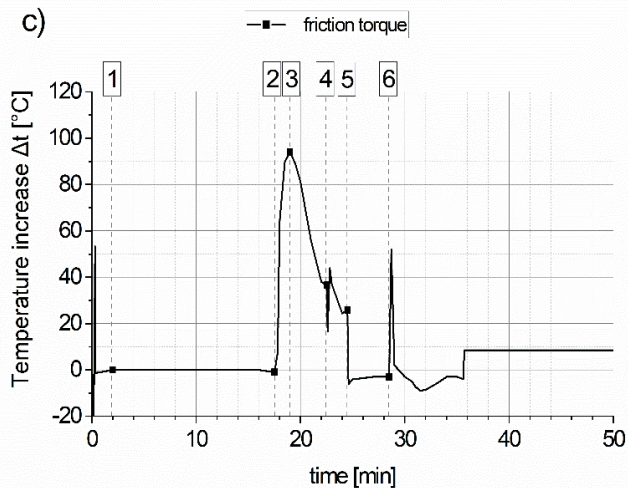
During the test conducted at the load of 0.2 MPa and no-water flow, bush damage due to overheating took place (Fig. 5). The presumption of the author was to terminate the test if the temperature in the bearing exceeded 50°C, meaning a temperature increase not greater than 30°C or if a concerning increase in the motion resistance was observed. The results of that test are presented in Fig. 5.

Fig. 5. Temperature and friction torque increase diagrams for bearing with elastic polymer bush. Test conditions: pressure=0.2 MPa, shaft revolution speed =10 rev/s, water flow=0 L/min. a) Water temperature increase diagram, b) Bush temperature increase diagram, c) Friction torque increase diagram, 1 - turning off the water flow, 2 - sudden increase in motion resistance, 3 - limiting shaft revolution speed to 100 rev/s and attempting to turn on the water flow, 4 - another attempt to turn on the water flow, 5 - stopping electric motor, 6 - momentary activation of the electric motor.

The process of simulating a malfunction was initiated by closing off the water flow through the bearing (1). Shutting off the water flow (1) resulted in a temperature increase of the water and the bush. The water temperatures on the inlet and outlet sides of the bearing were increasing at the same rate, and from the moment of closing the valve they were slightly higher than the bush temperatures (measured 3 mm underneath the sliding surface).

When motion resistance had increased (2), the author decided to continue testing, since the water temperature increased by only 8°C from the simulation start and did not exceed assumed 30°C. In less than two minutes temperature differentiation in the bearing was observed (3) and at this moment the valves were opened, the pump transporting water to the bearing was activated, and the revolution speed of the motor reduced from 10 to 1.7 rev/s (100 rev/min). The motion resistance started to decrease, but unfortunately no-water flow through the bush was observed and the bush and the water temperatures were increasing at a very rapid pace (segment 3-4).

According to the author, the flow of water through the bearing was impossible (3), since there was no clearance between the bush and the journal, and the lubrication grooves were blocked by the melted polymer. Additionally, inlet water temperature sensor did not indicate any inflow of fresh water (lack of temperature drop). Water flow was observed after second attempt at activation of the pump (4), resulting in a momentary drop of the water temperatures. The electric motor was turned off at (5) and turned on for a moment at (6).

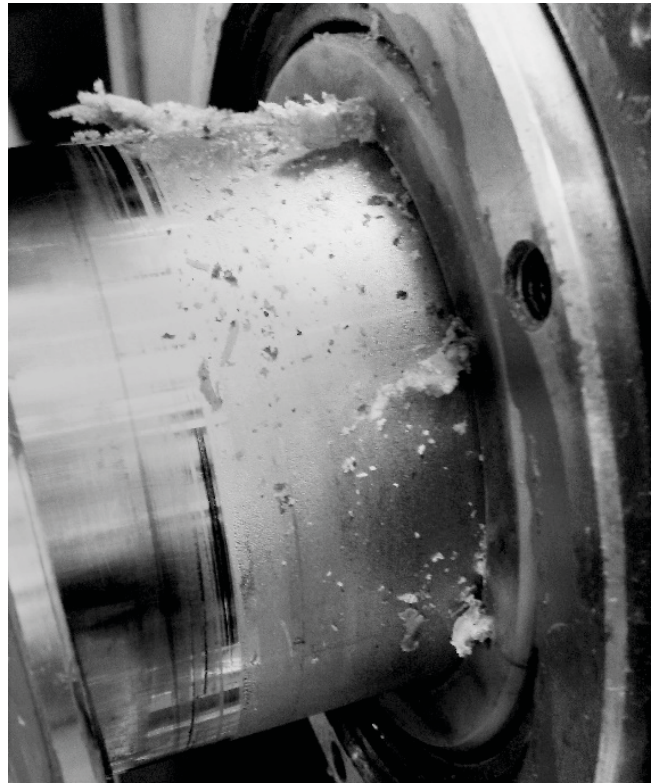
After disassembling the bearing's covers, the melted bush was visible on both sides of the bearing (Fig. 6).

Fig. 6. Disassembly of bearing's cover: lubricating grooves clogged with wear particles. Test conditions: pressure=0.2 MPa, shaft revolution speed =10 rev/s, water flow=0 L/min.

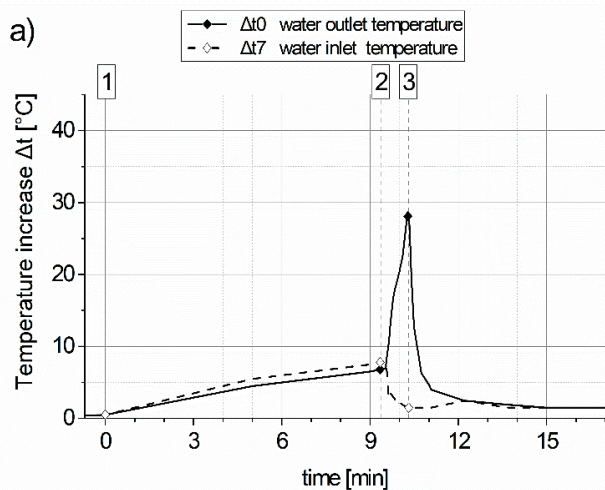
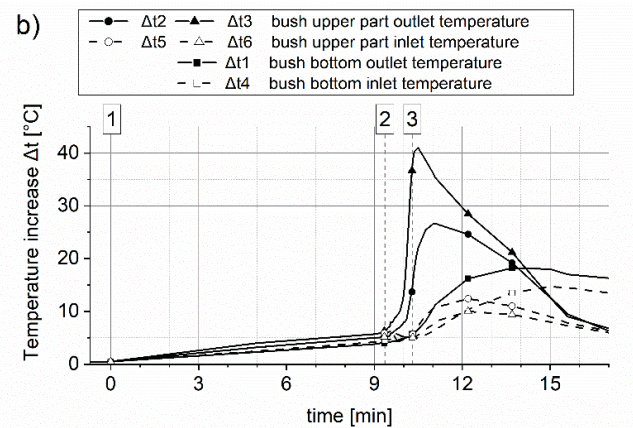
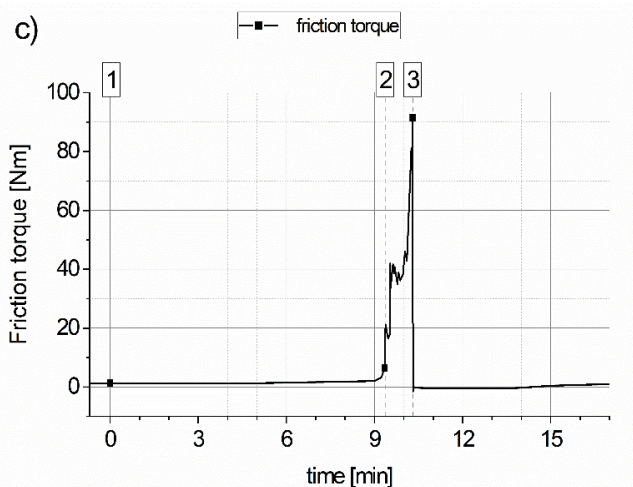
Fig. 8. Temperature and friction torque increase diagrams for bearing with elastic polymer bush. Test conditions: pressure=0.3 MPa, shaft revolution speed =10 rev/s, water flow=0 L/min. a) Water temperature increase diagram, b) Bush temperature increase diagram, c) Friction torque increase diagram, 1 - closing the water flow, 2 - sudden increase in the resistance of motion, 3 - stopping motor's operation.

Following the closing of the water flow (1), the temperatures of the water and the bush rise at a similar rate. After approx. 9 minutes into the test, a sudden rise in the resistance of motion occurs (2), thus the valves are being opened and the water pump turned on. This resulted in bringing down the temperatures on the inlet side of the bearing (Δt_5 , Δt_6 , Δt_7), but also in a sudden increase of the temperatures at the outlet (Δt_0 , Δt_2 , Δt_3). These temperature changes concerns the water and the upper part of the bearing, where lubricating grooves are placed. The outlet temperatures increase is a result of pushing out the hot water from the bearing and it might be additionally affected by water backflow phenomenon [49]. The opening of the fresh water flow did not affect the temperatures at the bottom of the bush (Δt_1 , Δt_4), since water mainly flowed through the lubrication grooves.

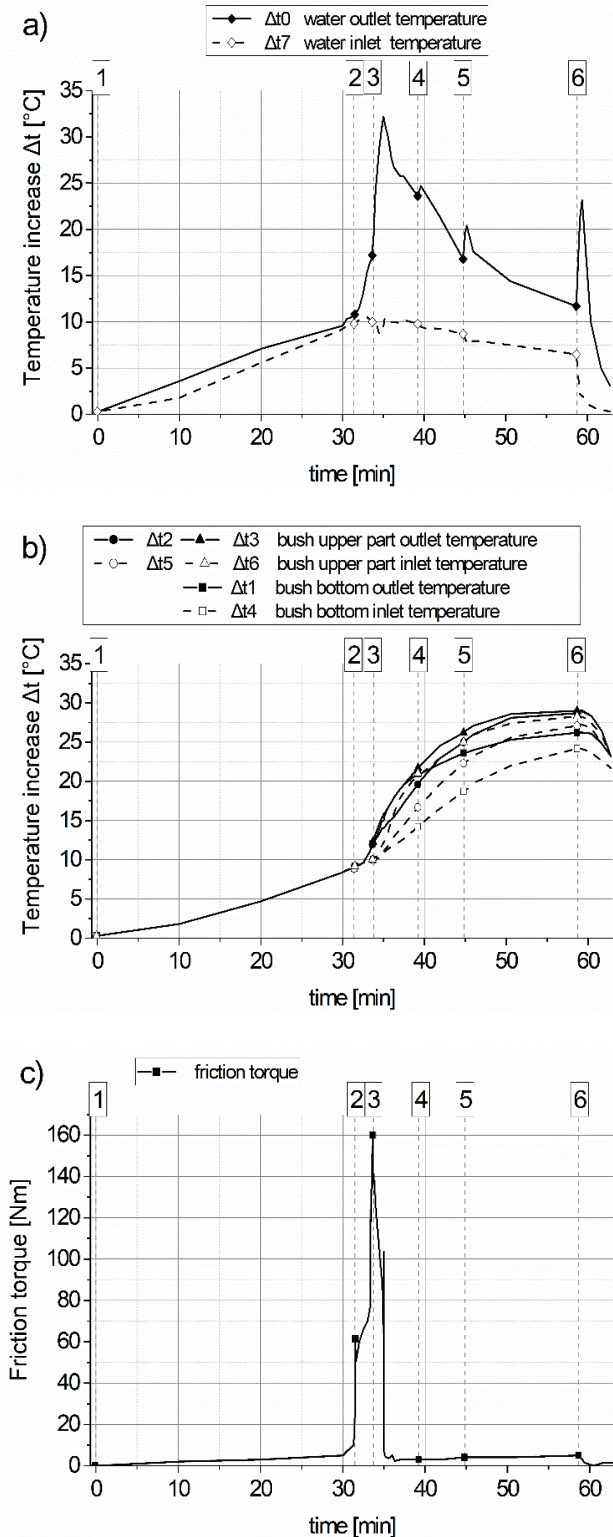
From the moment of closing the water flow through the bearing (1) the water temperature was growing faster than the bearing temperature. After 30 minutes of the bearing's operation at 0.4 MPa sudden increase in the resistance of motion was observed (2). At this point, the valves were opened and the water pump was turned on. Just a few seconds later the cover sealing was pushed out (on the outlet side) by steaming water (2). The steaming water began to leak out and, despite activating the pump, no-water flow through the bearing was observed. A moment later the motor was turned off (3). After switching the electric motor off, several attempts were made to activate the water pump (4,5). It was only after about 30

minutes from the moment of pushing the sealing out that the water flow through the bearing finally took place (6).

Fig. 10. Temperature and friction torque increase diagrams for bearing with elastic polymer bush. Test conditions: pressure=0.4 MPa, shaft revolution speed =10 rev/s, water flow=0 L/min. a) Water temperature increase diagram, b) Bush temperature increase diagram, c) Friction torque increase diagram, 1 - closing the water flow, 2 - sudden increase in the resistance of motion, turning the pump on, pushing out of the cover sealing by steaming water, 3 - stopping the motor, 4, 5, 6 - attempts at turning the water flow on.

The test demonstrates that the temperature of the water inside the bearing must have been 100°C, despite the fact that the outlet water temperature sensor indicated only 33°C just a moment before the sealing was pushed out.
