DEGRADATION OF THE CONCRETE RAILWAY TRACK BED LOCATED IN THE VICINITY OF THE LOADING WHARF

Maciej Niedostatkiewicz

Gdańsk University of Technology, Faculty of Civil and Environmental Engineering, Poland

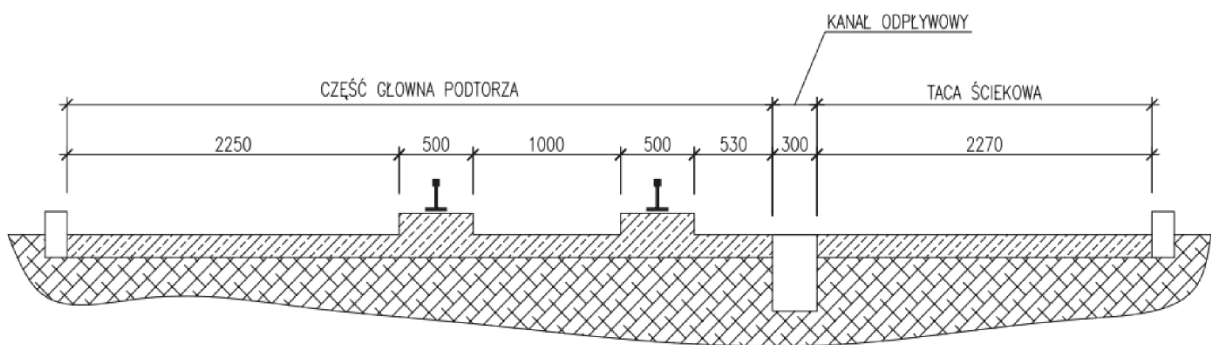
The 100 m long reinforced concrete track bed was located in the vicinity of the wharf and used for loading and unloading petroleum materials for rail tankers. The railway track was laid on a reinforced concrete track bed. The plate consists of three elements: the main part of the track bed, the drainage channel and the sewage tray (Fig.1 and Fig.2).

Fig. 2. Diagram of the concrete structure of the railway subgrade-stocktaking
