# Water-lubricated bearings of ship propeller shafts - problems, experimental tests and theoretical investigations

Wojciech Litwin, Ph. D.  
Gdansk University of Technology

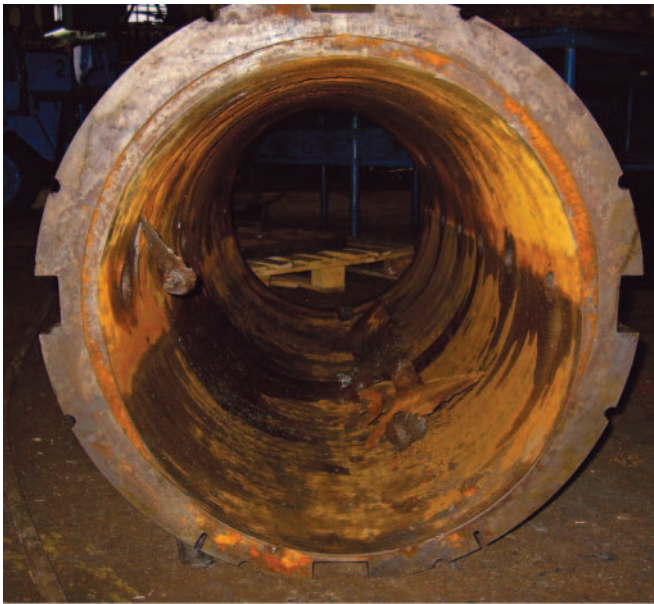
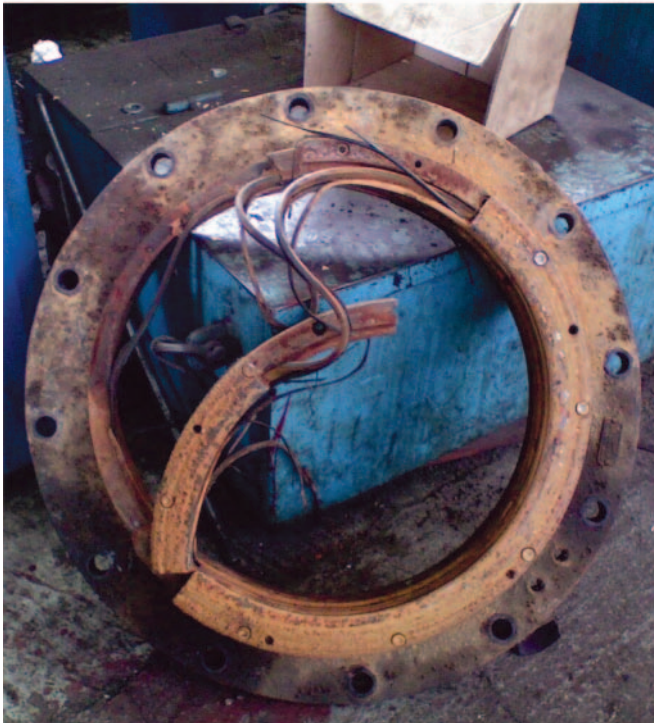
*Fig. 1. Completely damaged oil-lubricated slide bearing and sealing of ship propeller shaft*

as a lubricating medium, its leakage results in pollution of sea water. If ship's crew and owner do not immediately decide on docking and repairing the ship its serious failure will be possible to happen (Fig. 1).

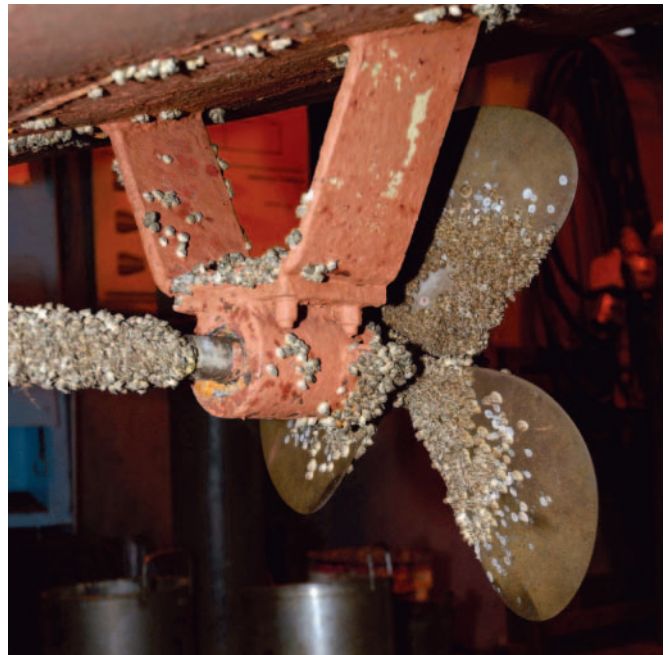
*Fig. 2. Cantilever open bearing of yacht's propeller shaft*

Each of them is characteristic of different properties and, resulting from them, advantages and disadvantages. Rubber effectively damps vibrations and is not sensitive to contamination, which is the reason for using it in e.g. cantilever open bearing systems (Fig. 2). It is important that contaminations which fell into rubber bearing accelerate its wear process only moderately. This concerns also hard contaminations, e.g. high-silica sand grains.

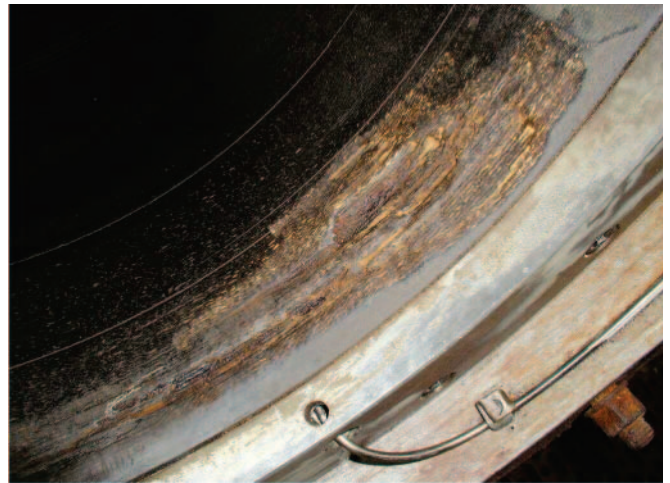
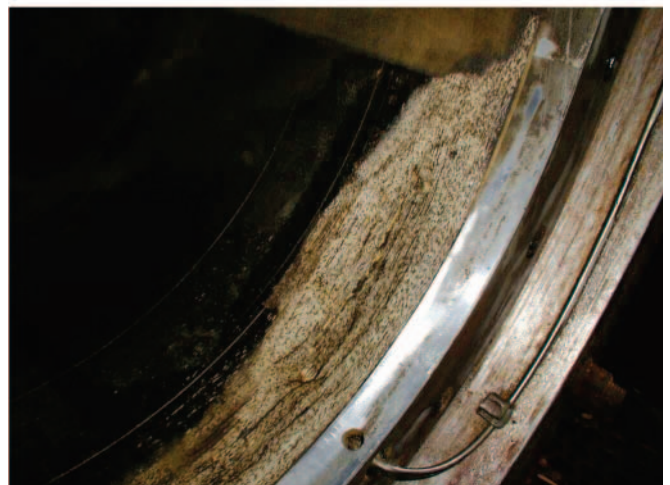
*Fig. 3. Damage of a composite bush, resulting from edge thrust resulting from skew position of shaft axis (up); during repair the damaged edge was grinded to avoid cracks and delamination of the composite (down)*

Composites, out of all the above mentioned materials, are characteristic of the largest value of rigidity modulus amounting to about 4500 MPa. Therefore they are sensitive to edge thrust in the case of shaft skewing. (Fig. 3), but they also have important merits. They are durable and highly resistant to form distortion which is a disadvantage of some homogenous polymer materials.

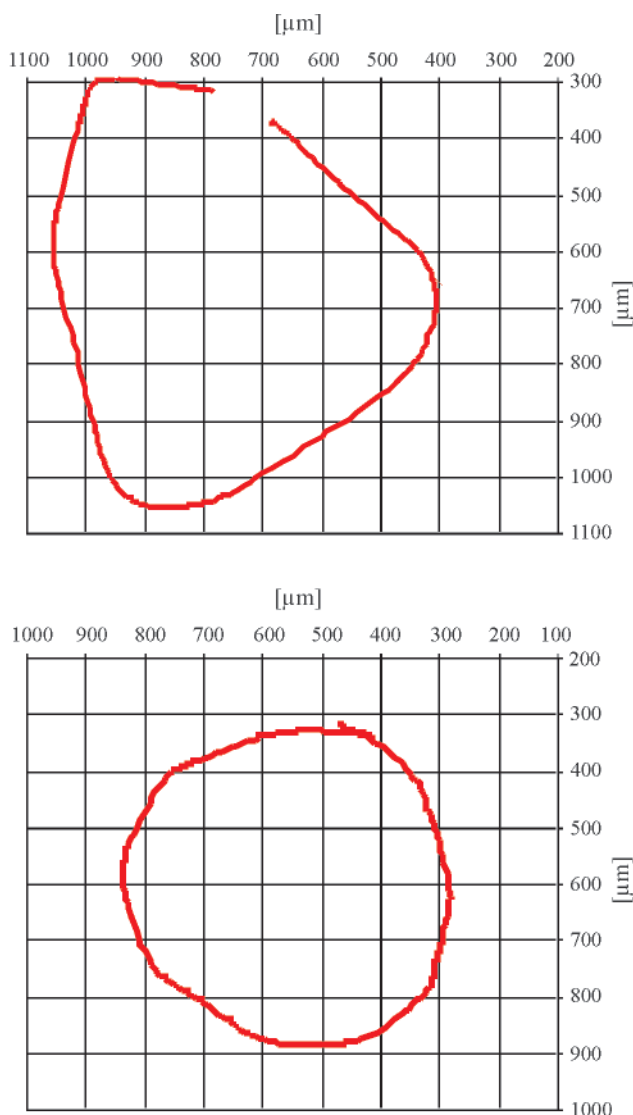
Fig. 4. Circles of gaps measured on both sides of a rubber bearing after its mounting in steel sleeve. Its form errors, especially lack of circularity, can be observed

to machine sliding surface of bearing after fixing its bush in a metallic or stiff composite sleeve. Usually a finished bush is ordered from producer who is usually better equipped with technological means to ensure an appropriate machining accuracy. Then the problem of proper mounting is only left for solving. As a rule the forcing method is not recommended as it may lead to bush deformation. Usually the contraction method is applied. The bush is cooled-down to a low temperature by using liquid nitrogen and next mounted into the sleeve. Unfortunately such method does not guarantee the highest accuracy hence bearing clearance may often differ from a design value. Additionally, if longitudinal lubricating grooves are made in the bush a danger of sliding surface deformation arises as the largest deformations appear usually in areas of the smallest thickness of the bush, i.e. in the vicinity of the lubricating grooves. Errors in manufacturing and mounting very often cumulate, which results in that bearing geometry differs significantly from the initially designed (Fig. 4). As can be observed from the below given diagrams of measured gap circle, significant deformations have appeared after mounting the rubber bearing of 100 mm diameter into the steel sleeve. Circularity and circularity errors are found significant. Hence it may be expected that in such bearing an intensive wearing-in process would happen and possible hydrodynamic load-carrying capacity would be very limited.

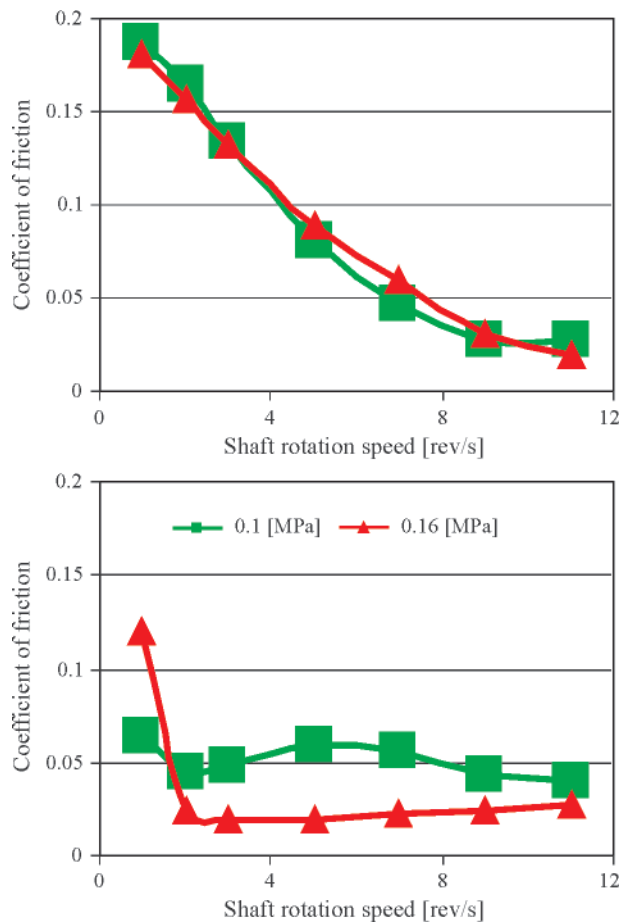
Fig. 5. Diagrams of friction coefficient values in function of shaft rotational speed; up side - the diagram recorded just after mounting the bearing, down side - the diagram obtained after several hours of running-in the bearing

Another technological problem is the achieving of possible high smoothness of co-operating slide surfaces. It is crucial because minimum thickness of lubricating film and hydrodynamic load-carrying capacity of bearing depends on surface roughness height. In the subject-matter literature publications dealing with influence of height and distribution of roughness on operation of hydrodynamic bearing, can be found. However as results from the author's experimental tests, this is bush roughness height which crucially influences hydrodynamical features of bearing [3,4]. The performed tests showed that running-in process of such bearing was very fast and a significant smoothness of slide surfaces was already reached after a few hours of operation. As a result, fluid friction state of operation was achieved faster (Fig. 5).

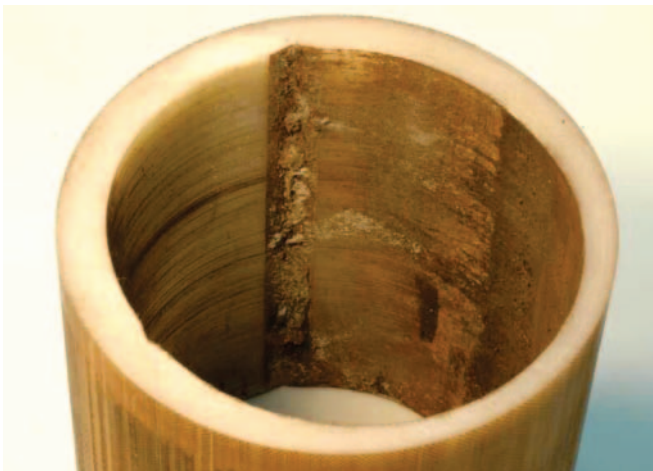
*Fig. 6. An unsealed sea-water-lubricated bearing which was exposed to pollution and fouling*

Ship water-lubricated bearings can have different forms recommended by their manufacturers. Such differences concern both values of recommended clearance in bearings and magnitude and number of longitudinal lubricating grooves and their suggested location as well. For fear of clamping the bush material exposed to water some producers recommend to increase clearance values. Most of recognized producers of ship slide bearings recommends to make certain number of lubricating grooves led along the bush. They play a significant role. Due to them, cooling water flow rate increasing is possible. It has a great importance as polymer bush practically makes heat transfer from friction zone to housing impossible. Additionally, the grooves, especially in the systems of open cantilever sea-water-cooled bearings, make it possible to more effectively remove wear products and contaminations from the bearings (Fig. 6).

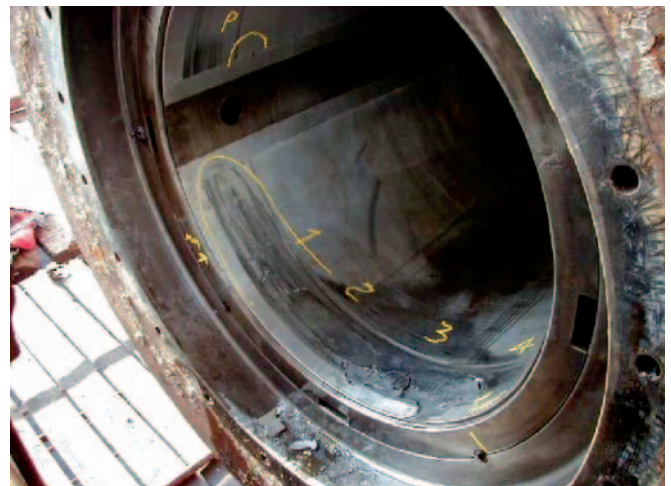
*Fig. 7. A white metal bush of oil-lubricated bearing, damaged due to edging*

Appropriate alignment of shaftline and bushes is the next important factor which directly influences lifetime of bearings; therefore mounting accuracy is of a special importance. In the case when mounting errors happen the skewing of shaft axis versus bush axis may occur. As a result load-carrying capacity of the bearing will be limited. In the extreme case the so-called edging phenomenon and associated fast progressing wear can appear because values of allowable contact pressure are locally exceeded. Bearings fitted with rigid ceramic, metallic or composite bushes are especially sensitive to the phenomenon (Fig.7).

The shaft axis skewing leads to decreasing load-carrying capacity of bearing, and in extreme cases, when rigid bush materials are used, the so-called edging occurs as a rule (Fig.7). It results in an intensive local wear of bush material and sometimes also in shaft failure.

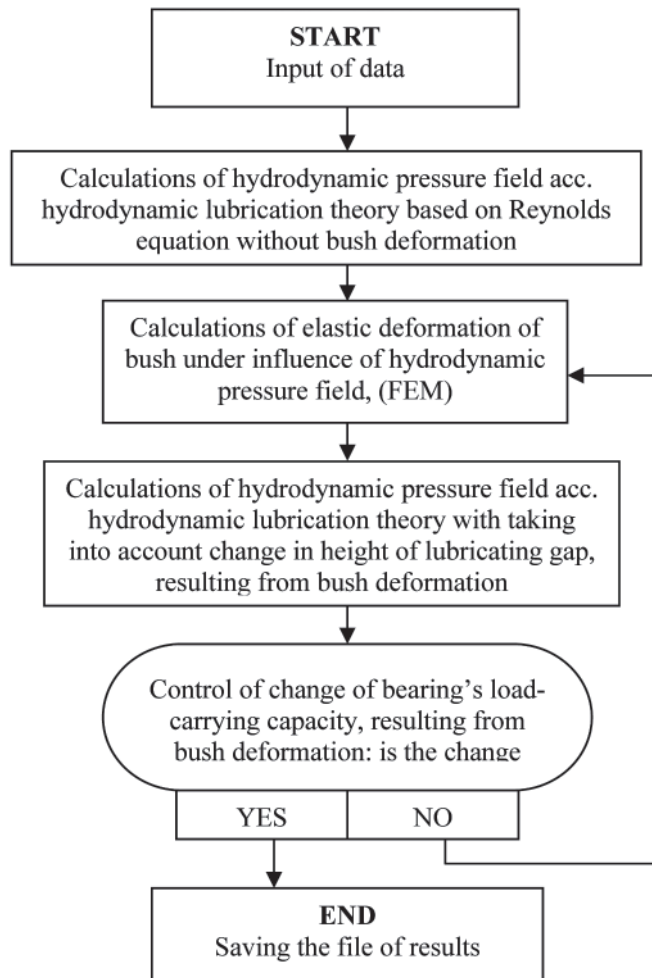
Fig. 8. Schematic diagram of the calculation method

Apart from the experimental tests the teoretical research is also conducted. In this paper are presented calculation results obtained by using the author's original software based on hydrodynamic lubrication theory applicable to elastic bush material (EHL). The software is composed of two modules: the program based on hydrodynamic lubrication theory, written in FORTRAN language, and the module based on the finite element method (FEM) in the form of macro to a commercial software. Schematic diagram of the calculation method is presented below (Fig. 8). The calculations are performed in an iterative mode. Generally, a satisfactory result can be obtained after twenty iterations at the most (Fig. 9). Problems with achieving correct results appear in the case of extreme conditions of operation with very thin lubricating films.

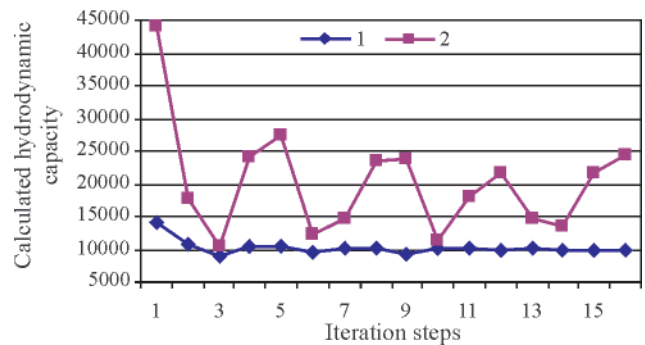
Fig. 9. Diagrams of calculated values of load-carrying capacity of a bearing in function of number of successive iteration steps:  
1<sup>st</sup> series – stable solution was achieved;  
2<sup>nd</sup> series – a convergent result was not achieved

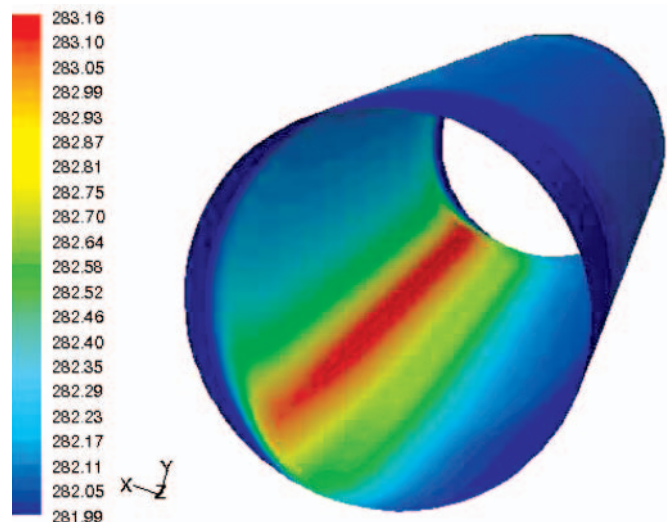
Fig. 10. Temperature distribution in lubricating film of a water-lubricated bearing, calculated by using a commercial software

The calculations were performed for the isothermal model. As results from the temperature distribution calculations (Fig. 10) and test-stand measurements the rise of lubricating film temperature is very low and amounts to less than 5°C usually. Therefore in the calculations the minimum change of viscosity of lubricating medium as well as of bush material properties, resulting from local rise of temperature, may be neglected.

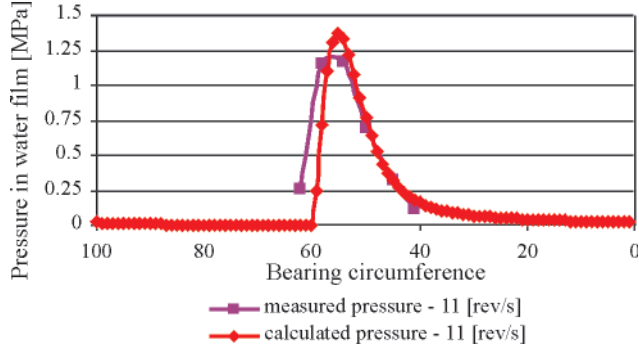
Fig. 11. Comparison of results of pressure field measurements and calculations

Results of the calculations were verified experimentally. They confirmed that the applied calculation method is correct. It is rather hard to estimate calculation error as to accurately measure lubrication gap height is deemed questionable. In the author's opinion the calculation error does not exceed 20%.

Results of calculated and measured hydrodynamic pressure distributions in a water-lubricated bearing, are presented below (Fig. 11.)

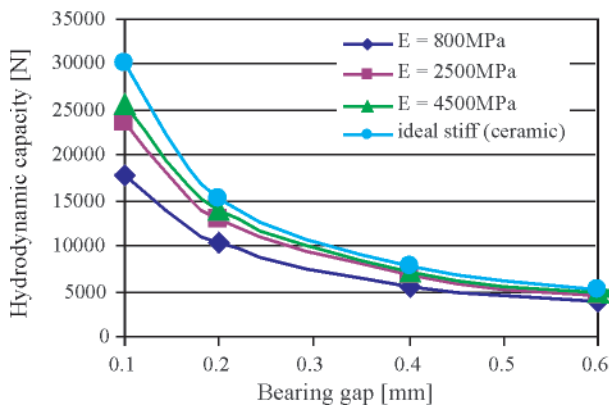
Fig. 12. Influence of bearing diameter clearance (bearing gap) and rigidity modulus of bush material on maximum load - carrying capacity of the bearing; shaft diameter of 100 mm, bush length of 400mm

Diameter clearance is of crucial impact on slide bearing qualities. The tested bearing achieves usually its largest hydrodynamic load-carrying capacity at the relative clearance value in the range from 0,001 to 0,002 (Fig. 12). However such value would be hardly applicable in practice. It should be remembered that in the typical case a completely finished polymer slide bush is seated by using shrinkage method. Therefore it is usually hard to achieve a precise value of bush inner diameter hence also a precise value of diameter clearance after seating the bearing. An additional problem is water absorption, typical for most polymers. Bush material swells as a result of the process. Because the bush is seated in a steel housing all the swelling of bush material makes bearing inner diameter smaller, which leads to significant risk of clenching the bush onto shaft and bearing blocking. It creates serious danger and therefore bearing manufacturers recommend as a rule to increase bearing gap.

From the performed calculations it results that rigidity modulus greatly impacts load-carrying capacity of high-loaded slide bearings (Fig. 12). It is associated with elastic deformation of bush material under hydrodynamic pressure

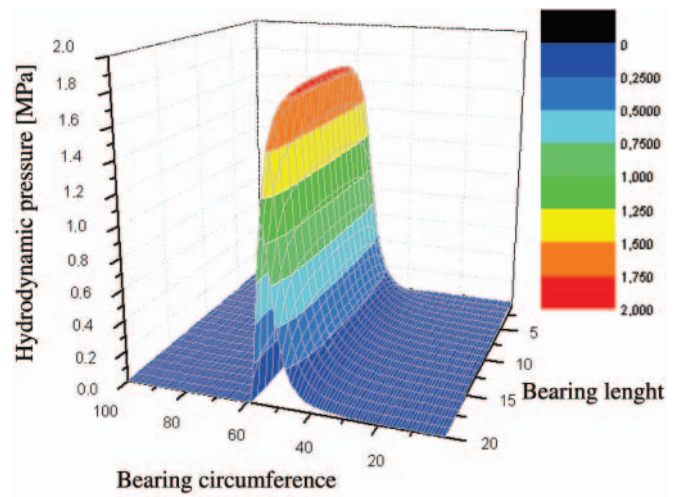
Fig. 13. Diagram of the calculated pressure field in the bearing fitted with perfectly rigid bush

of lubricating film. In effect the largest deformation takes place in the middle part of the bearing, and only slight ones - near its edges. For this reason in the central part of the bearing the lubricating gap height becomes larger and, in consequence, load-carrying capacity of the bearing - lower. (Figs. 13, 14, 15).

In the diagrams the calculated pressure field of a high-loaded bearing with 5 $\mu$ m lubricating gap height, is presented.

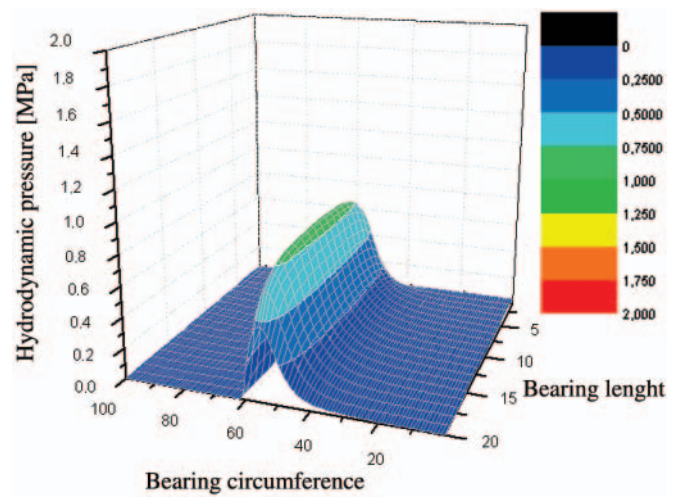
Fig. 14. Diagram of the calculated pressure field in the bearing fitted with elastic bush of 800 MPa material rigidity modulus

Attention should be paid to the fact that only the central part of the bush has been deformed. Therefore the smallest value of lubricating film thickness has occurred at the bearing's edges. In the case of increasing load specific situation happens in bearing of the kind: its central part operates in fluid lubrication regime but in its near-edge zones mixed friction appears and, in consequence, progressing wear process develops. Occurrence of the phenomenon has been confirmed by the performed experimental tests.

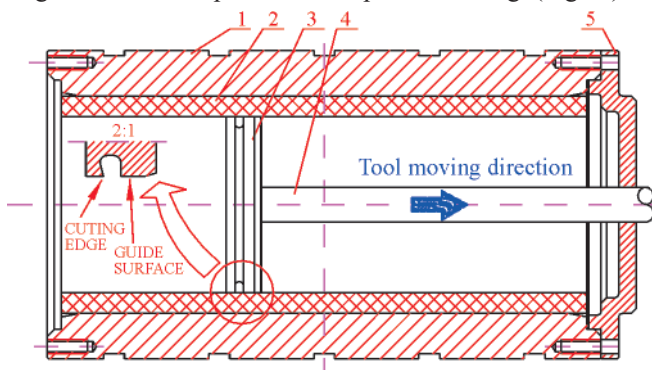
Fig. 16. Internal pull-broaching of polymer bearing bush. 1 – steel sleeve, 2 – polymer bearing bush, 3 – form tool, 4 – pulling rod, 5 – cutting disc

The experimental tests in question were performed for a few kinds of bush material as well as various clearance values. The bush was turned to achieve roughness direction parallel to sliding direction. A problem was to obtain the roughness having direction perpendicular to rotation direction. Therefore a machining method was elaborated similar to pull-broaching. Through a preliminarily machined opening in the bush were introduced purpose-designed cutting discs of successively larger diameters to perform bush pull-broaching. (Fig. 16).

Due to longitudinal motion of the tool roughness arrangement perpendicular to sliding direction was achieved. However in practice it turned out that certain materials, e.g. composites appeared hardly machinable as they deformed elastically. Such polymers, like polyethylene or polyamide, were less troublesome during pull-broaching operation. Despite setting the minimum thickness of cutting layer surface quality after pull-broaching operation was distinctly lower than that after turning.

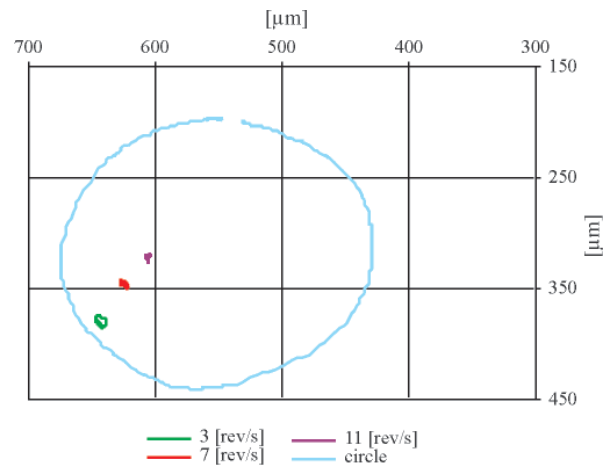
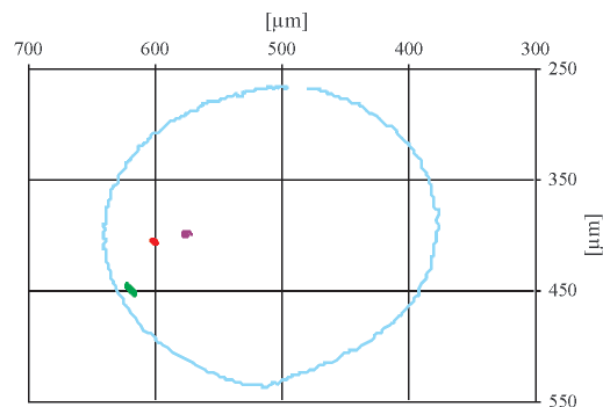
Fig. 17. A bearing fitted with PET polymer bush of 0.0027 relative clearance value; up – the bearing with turned bush; down – the bearing with pull-broached bush

The performed tests showed that roughness topography, i. e. its arrangement has not any significant impact on bearing qualities [7]. Below, an example comparison of the experimentally recorded shaft axis trajectories, is shown. The observed very small differences in the journal's position demonstrate that the state of surface has negligible effect on hydrodynamic bearing qualities. Worth adding that the tests were performed just after mounting the bearing and before bush material running-in.

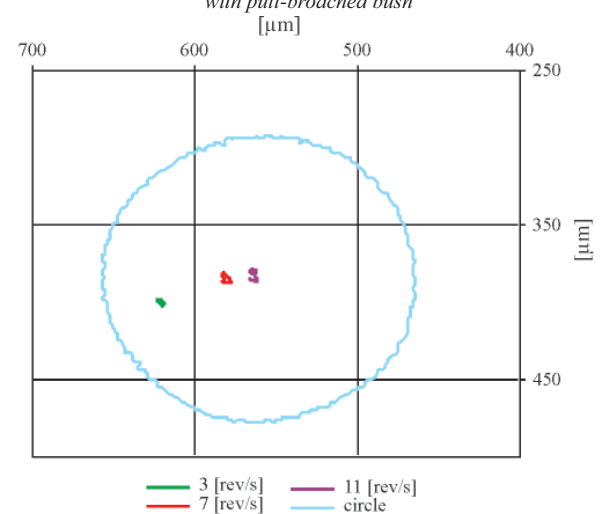
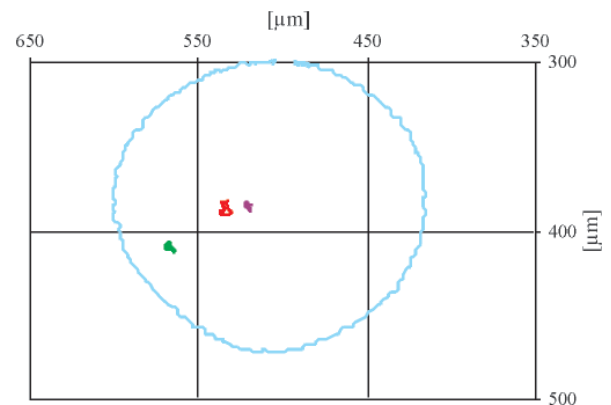
Fig. 18. Bearing fitted with composite bush of 0.0017 relative clearance value; up – the bearing with turned bush; down – the bearing with pull-broached bush

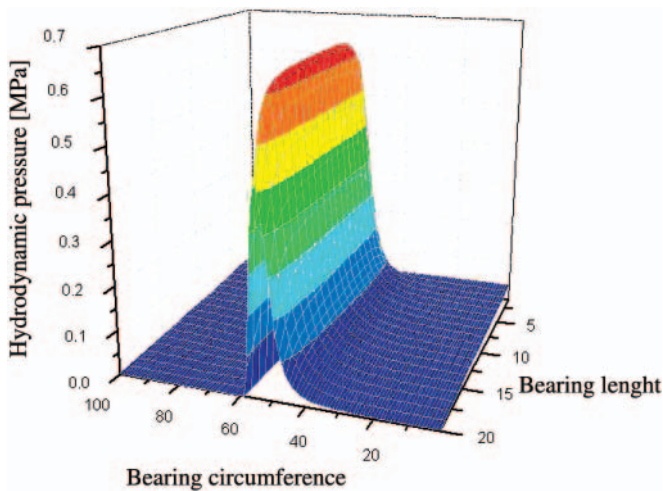
Fig. 19. Calculated pressure field in a bearing fitted with elastic bush of the material rigidity modulus  $E=800$  MPa

In the below attached diagrams is presented a change of form of calculated pressure field, which results from the skewing of shaft axis. In the analyzed case the theoretically maximum value of hydrodynamic load-carrying capacity of the bearing decreased by 25% as a result of the shaft axis skewing.

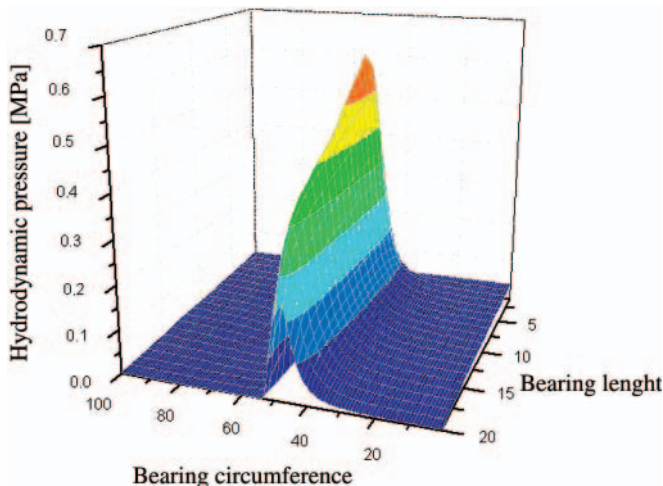
Fig. 20. Calculated pressure field in a bearing fitted with elastic bush of the material rigidity modulus  $E=800$  MPa, and shaft axis skewed against bush

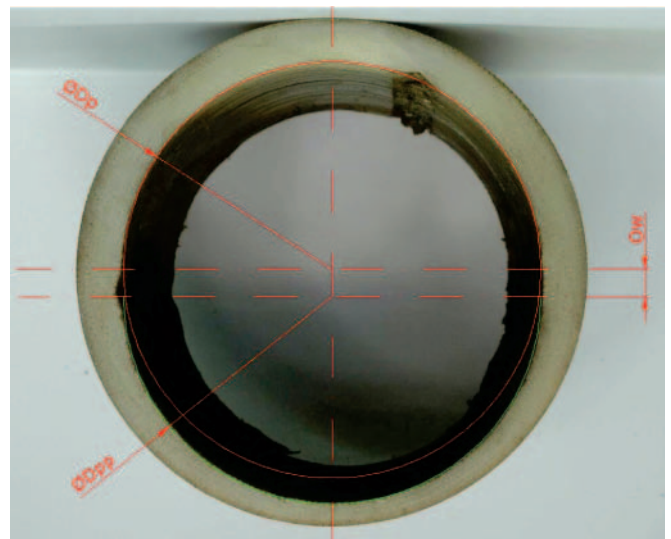
Fig. 21. Sliding bush of a water-lubricated bearing subjected to long-lasting operation which resulted in a significant wastage and associated ovalization of the bush

Bearing operation performed not always in optimum conditions as well as designing and mounting errors usually lead to fast progressing wear of bush material. Consequently, it is hard to predict which form of bush would be finally obtained. From an analysis of experimental tests with many bushes as well as experience from their long-lasting operation on ships it results that bush loses its initial cylindrical form usually due to progressing wear. It step by step obtains a form of truncated cone and undergoes ovalization. In the below given figure it can be observed that the bush ovalization resulted from its long-lasting work. In the lower part of the bush a significant material wastage occurred and the bush axis was displaced by  $O_w$  value.
