INFLUENCE OF SOLID PARTICLE CONTAMINATION ON THE WEAR PROCESS IN WATER LUBRICATED MARINE STRUT BEARINGS WITH NBR AND PTFE BUSHES

Ewa Piątkowska*

Gdańsk University of Technology, Poland

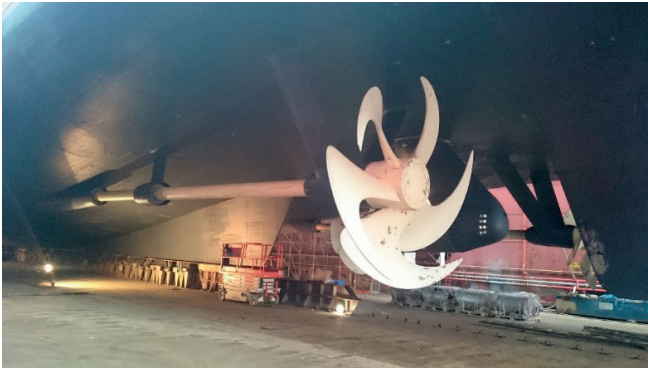
Special consideration should be given to the working conditions of the propeller shaft strut bearings (Fig.1). It is common to utilize bearings lubricated with seawater that surrounds the hull of vessels, where there is not control of the water flow and the water is not filtered. Therefore, when a vessel is operated in shallow or inland waters, various types of contaminants tend to enter the friction zone, resulting in accelerated wear processes.

Fig.1. Propeller shaft strut bearings [1]

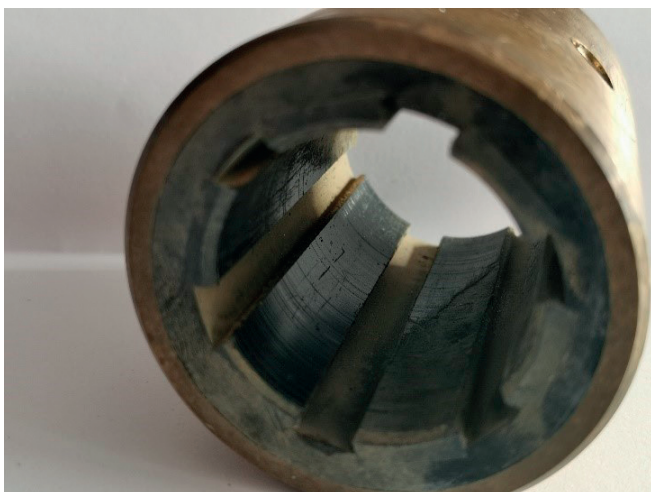
Fig. 5. The PTFE sliding bush (B)

Traces of wear caused by friction are visible on both internal surfaces of the bushings. The circumferential grooves were the result of sand particles getting between the shaft journal and the bush, but deeper grooves were seen in the NBR bush. As for the journals, the rubber bushings had the greatest wear in the middle of the bushing and at the edge of the load application. On the other hand, the wear of the PTFE bushings was evenly distributed over the entire surface of the joint. Inside, there were visible fragmented sand particles embedded in the longitudinal grooves, which could have

caused detachment the upper layer of the sleeve material, as shown in Figure 5.

The observations were also made for the NBR and PTFE sliding sleeves. The surface condition after cooperation with a steel journal lubricated with water containing solid particles is shown in Figures 4 and 5 for the NBR and PTFE, respectively.

Due to the observations of the bushings and the geometric structure of the journals, it was concluded that the NBR was more susceptible to deformation; damping vibrations also turned out to be worse than for the three-layer PTFE bushings. Factors that could have influenced such a course of the wear process of the sliding sleeves are the hardness of the material of the sleeves and the geometry of the sleeves. Particulate pollutants, like the sand from the Radunia River, can act as a cutting tool, especially for soft materials. Sand between the bush and the journal „sticks” into the material of the bushing, destroying the inner surface of the bush and the shaft journal at the same time and forming circumferential grooves on its surface. The active surface of both bushings was different due to the different number of grooves arranged longitudinally along the entire perimeter of the bushings. There were 8 NBR bushings and 6 PTFE bushings, which could indicate that the load field (i.e., the actual load) of both bearings operating under the same conditions was different.
