# STUDIES ON THE EFFECTS OF COLD STARTS OF THE SHIP MAIN ENGINE

*This article presents the influence of various ship's operational conditions occurring during manoeuvres related to entering and leaving the ports and mooring operations. Frequent starts and stops of the ship's propulsion unit are then required, which affect the variability of the energetic loads of the ship's power plant, causing accelerated, non-design wear of the ship's main propulsion engine. The effects of cold start-ups of the main ship engine are the subject of this study. Conditions of the engine inlet valve damage process are discussed. The physics of the degradation process leading to air inlet valve damage was considered. Laboratory tests of structure continuity and their results are discussed, and the valve material defects were excluded as the cause of the damage. The causes of repeated damage to the inlet air valves were identified. The effectiveness of the performed corrective measures was confirmed by a documented control test of the engine start-up. The article is a utilitarian premise for the requirements of the Classification Society.*

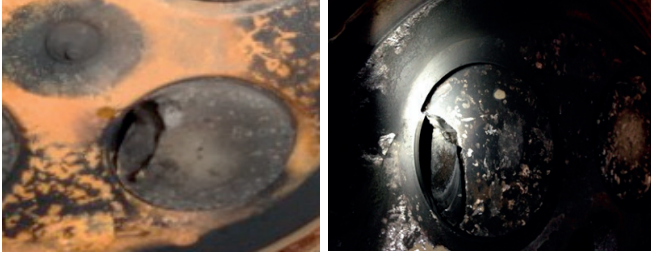
Fig. 3. View of a defective inlet valve of the Deutz 68M628 main power engine.

This process occurs with irregular frequency and causes different forms of tribological wear of inlet valves. Fig. 3 shows endoscopic images of a damaged inlet valve mounted in the cylinder head of a Deutz 68M628 main power engine of 1715 kW.

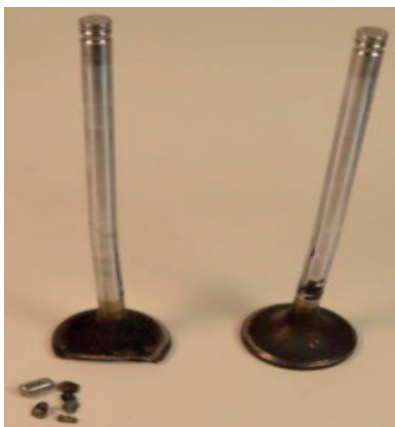
Fig. 5. View of studied damaged valves.

Organoleptic examination of the first valve revealed a bent stem and scratches in its upper part. These proved the existence of resistance to motion in the valve stem guide and defective operation of the “rotocap”. The second valve also had a bent stem and a partly broken off head. The view of the tested valves is shown in Fig. 5.

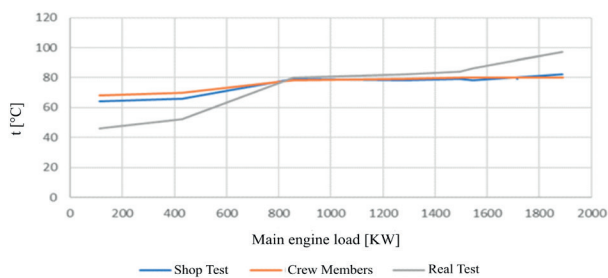
Fig. 13. Dependence of cooling water temperature on the main engine load: blue line - measurement from engine shop tests; red line - measurement taken by the crew; grey line - measurement taken for the sake of the case study.

oil purifying system and, consequently, the engine energy state, it was found that the temperature of the heating water and, therefore, the temperature of the engine before the start-up was only 20–25 °C. Starting of the engine in such a defined energy condition is known as the so-called “cold start”. The correct temperature of the low-temperature cooling circuit (LT – Low Temperature) of 60 °C, compliant with the operational documentation, was established only after 20 min of engine work at its load corresponding to about 50% of its nominal power. Looking for the correctness of the process course, Fig. 13 shows comparative diagrams of the engine cooling water temperature variation as a function of load. Diagrams were made during shop tests, by the crew of the ship, and for the purpose of verifying the engine cooling circuit functionality during the manoeuvres and sea passage (after the transient start-up process).

To ensure the design operating conditions of the studied engine, the inlet cooling water temperature must not be lower than 60 °C. The inlet water temperature measurements made for the research in Fig. 13 show a lower temperature, while the outlet water temperature took correct values in the range of 78–82 °C.

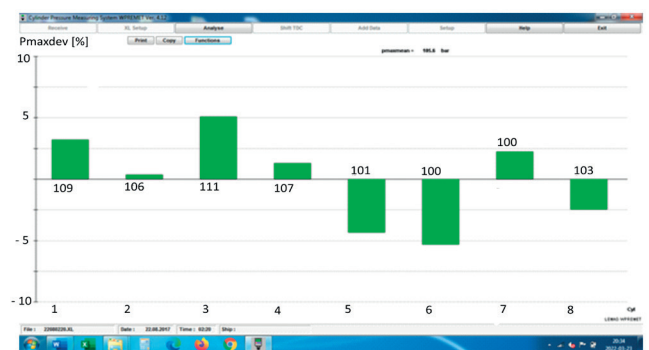
Fig. 16. Deviations from the mean value of the combustion pressure at the beginning of the second stage of engine start-up.

An examination of the run of the start-up and the initial phase of engine operation showed an uneven distribution of loads on individual units. Lack of balancing of unit loads significantly hinders the start-up and the start of stable engine work and, thus, its ability to accept the load. The cylinder imbalance that is occurring, represented by the compression pressure, is shown in Fig. 16, with the distribution of the combustion pressure difference between the units.

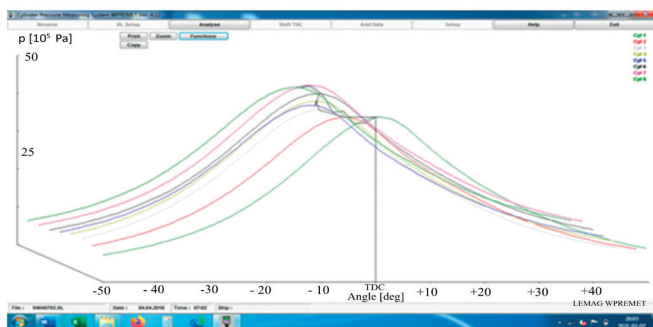
Fig. 20. Combustion pressure runs in the ship main power engine as a function of the crankshaft rotation angle, after correction actions, taken at the load of 50% of the nominal engine power.

The performed corrective actions balanced the load distribution across the engine units to some extent, as shown by the engine indicator graph in Fig. 20.

The recorded runs of the pressure show more balanced loading of individual piston-crank systems. The effectiveness of the performed corrective actions, taking into account the conclusions of the conducted tests as fully as possible, was confirmed by the successful control tests of the engine start-up and its further operation without unscheduled repairs and valve damage.

On the basis of the partial conclusions from the research, corrective actions were carried out during stay in port and verified during start-ups and registration of initial periods of engine work. Cooperation of the engine start-up time controller with the crankshaft speed meter was verified. Temperature controllers of the engine heating water and the state of the non-return valve at the connection of the engine heating and cooling circuits were corrected. Operation of the thermoregulatory valve adjuster in the engine circulating oil purifier system was adjusted.

The automatic setting of the starting fuel dose was adjusted. Settings of the injection pumps (fuel doses) and the moment of starting the fuel injection were corrected. The correction was made on three injection pumps with the use of a fuel dose corrector, included in the equipment of the injection pumps. The correctness of the timing phases of the mutual angle of rotation of the crankshaft and the camshaft was checked using an electronic meter.
