A NEW APPROACH OF COASTAL CLIFF MONITORING USING MOBILE LASER SCANNING

Rafał Ossowski
 Paweł Tysiąg
 Gdańsk University of Technology, Poland

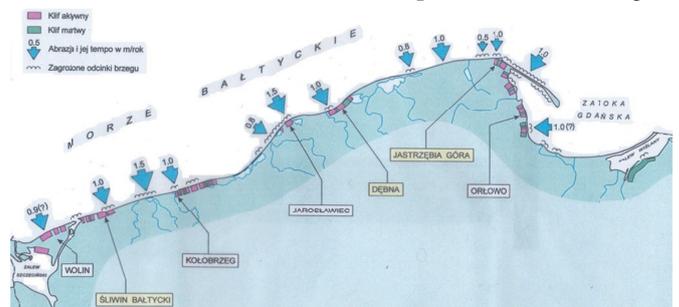
Fig. 1. Locations of cliff coastlines in Poland and their abrasion rate in years 1980-90 [1,2]

The stability problems of coastal cliffs in Poland are the object of continuous interest of maritime administration (Maritime Offices), local self-governments, and residents of towns situated on the edges of cliffs. This type of coastline is observed in more than ten segments of Polish coast (Fig.1).

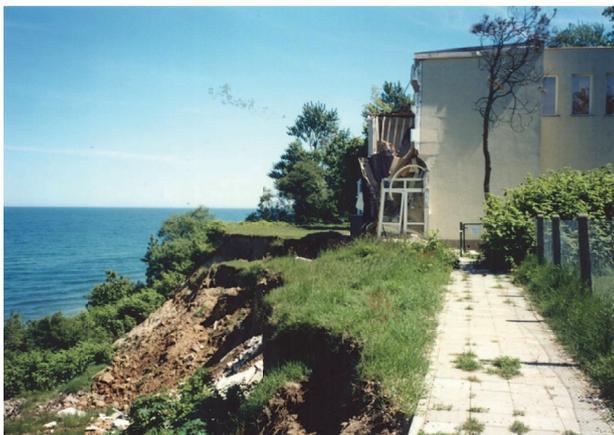
Fig. 2. The leisure centre "Horyzont" situated on the edge of an active cliff and damaged in 2002.
(photo courtesy of W. Subotowicz)

The landslide hazard of the Jastrzebia Gora cliff has been known for several decades. The interest of the society and local self-government in this part of the coast increased in 1988 when the created landslide endangered the leisure centre "Horyzont" (Fig. 2). The average multiannual cliff abrasion rate in this region is approximately equal to 1m/year [1].

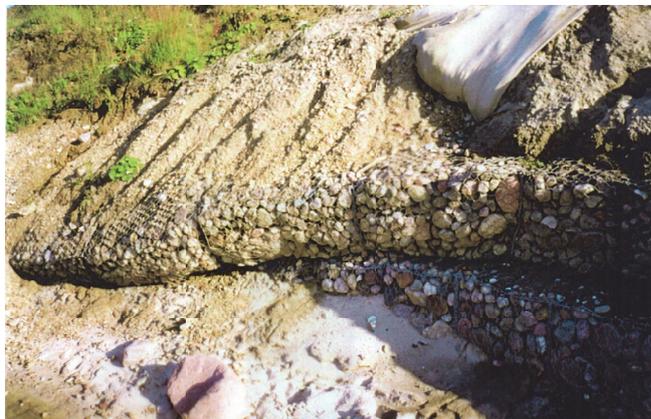
Fig. 3. Gabions composing the seawall in the region of "Bałtyk", damaged in 1998
(photo courtesy of W. Subotowicz)

abovementioned cliff segment at Jastrzebia Gora. It had the form of a seawall consisting of gabions. At first, it was built along the eastern cliff part, of 200 m in length, where the partially damaged leisure centre "Horyzont" was situated. Unfortunately, first damages of this seawall were already observed as early as in 1998 (Fig. 3).

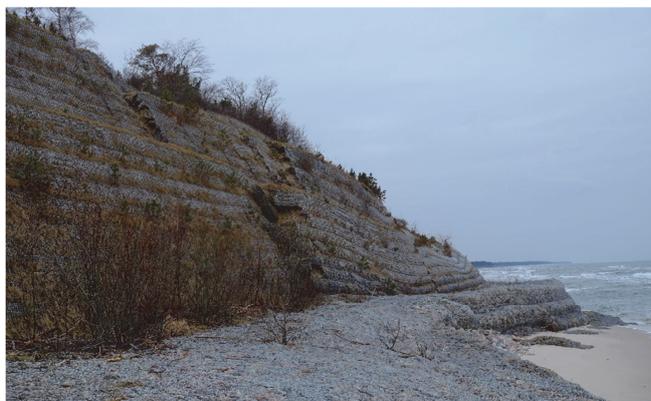
Fig.4. Degradation of reinforced cliff part at Jastrzebia Gora – situation of January 2017.

A general conclusion from the above situation is that all past protection measures revealed low durability (see Fig. 4). Consequently, permanent monitoring of the cliff is indispensable for the safety of tourists and residents.

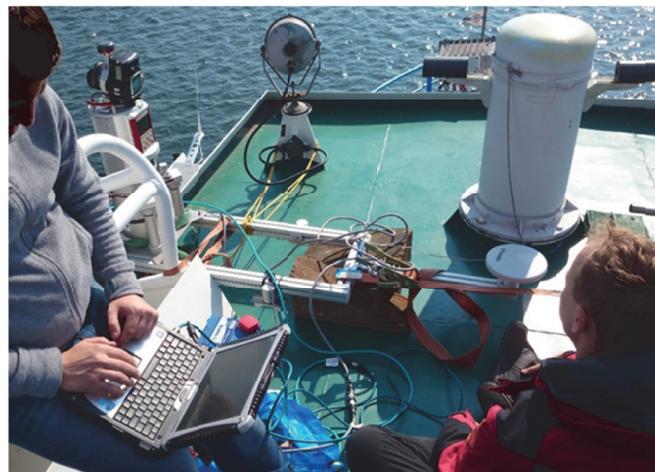
Fig. 5. Scanning from watercraft

The Jastrzebia Gora cliff was scanned using the mobile system VMZ-400 produced by Riegl GmbH. The system consists of the scanner VZ-400, initially designed for stationary scanning, and the dual frequency GNSS (*Global Navigation Satellite System*) receiver, coupled with the IMU (*Inertial Measurement Unit*), which is responsible for precise evaluation of angular displacement of the platform along its three axes, i.e. in *pitch*, *yaw* and *roll* directions. It is noteworthy that the VMZ-400 system is fairly frequently used in mobile systems [10], for instance to perform measurements in harbours and rivers/channels [11], while scanning from the open sea is still an innovative solution which has to meet severe introductory requirements. A problem to be dealt with when performing maritime scanning is sea undulation, which, after exceeding some critical level, can unfavourably affect the quality of the recorded results.

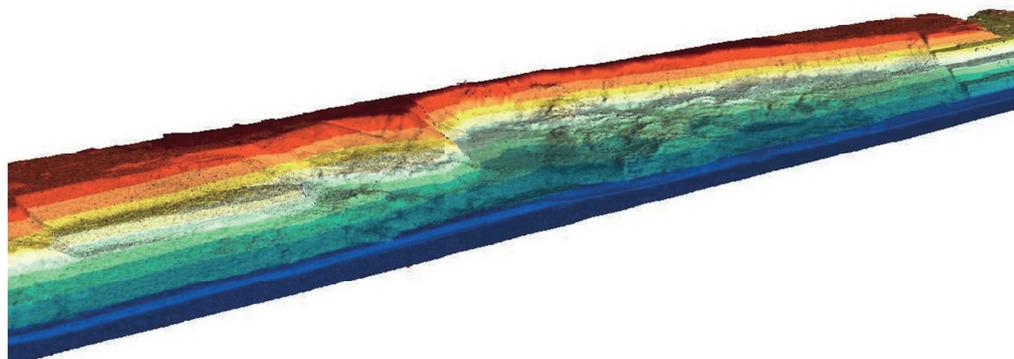
Fig.6. Results of laser scanning – 3D model of the cliff surface.

To obtain 3D data for the cliff model, basic scanning from the sea was performed along the coast segment from the port of Władysławowo to the surroundings of the North Obelisk at Jastrzebia Gora (from about km 125 to about km 140). These measurements were complemented by the results of terrestrial scanning, thus providing opportunities for creating a 3D model of the examined cliff (Fig.6). An essential problem in the applied measurement technique appeared to be filtration of raw data to extract the numerical model of the area. For this purpose, an algorithm has been developed by the authors in which the second-degree surface approximation was used in hierarchical process for surface estimation [17].

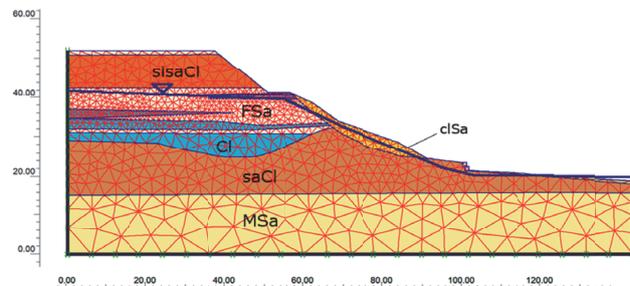
Fig.8. Geotechnical cross section of km 133.8 and its discretisation

on the results of laser scanning from the sea, complemented with terrestrial scans. The geometry of these sections is shown in Figs. 8-9.

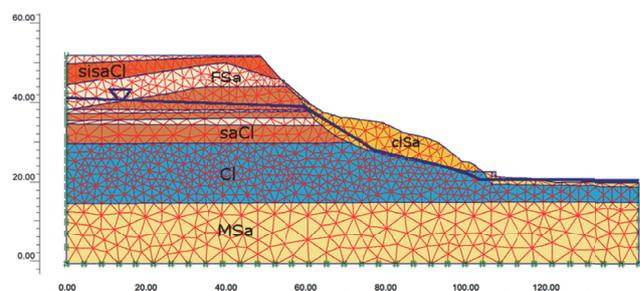
Fig. 9. Geotechnical cross section of km 134.1 and its discretisation

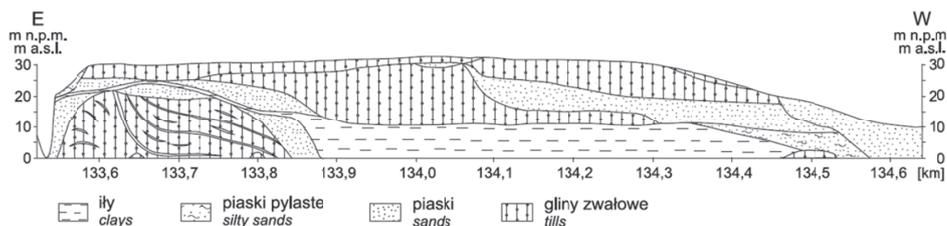
Fig.7. Geological longitudinal section of cliff wall [12]

The stability analyses were performed for 2 characteristic cross sections of the cliff massif, which has a relatively complicated geological structure and is characterised by high spatial variability (Fig. 7). The first cross section is situated at km 133,8, near the descent from the cliff top to the beach. Heavy pedestrian traffic of tourists is observed in this area, therefore of high importance is to determine whether this descent is or is not threatened by the occurrence of landslide. The other cross section, at km 134.1, has been selected in direct vicinity of the leisure centre “Horyzont”, which is situated close to the edge of the cliff.

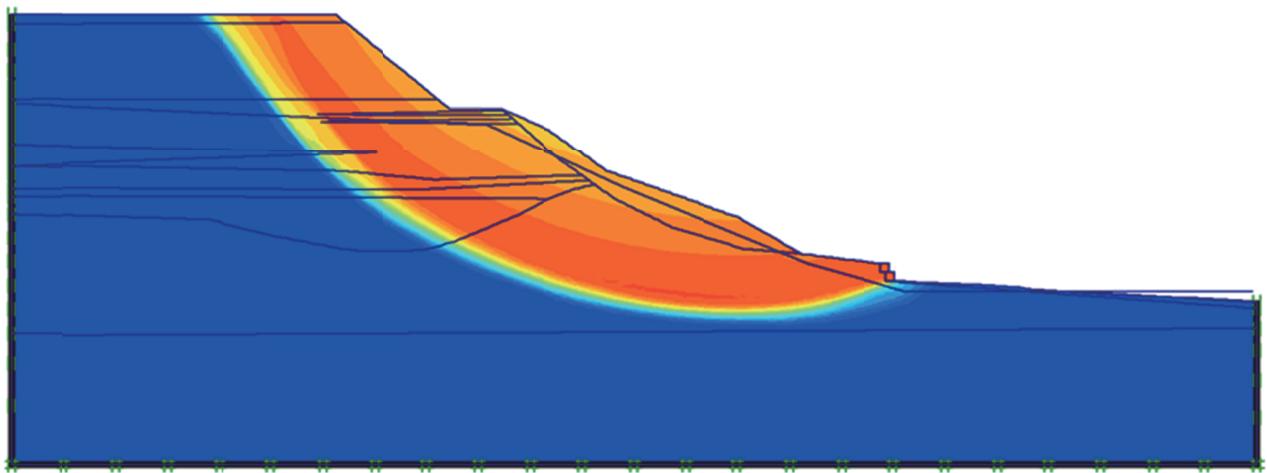
Fig.10. Global destruction mechanism (orange indicates failure) in cross section 133.8 (SF=1.05)

The stability calculations performed for the selected cross section geometries have demonstrated the global mechanism of destruction and gave the following values of stability factor: SF=1.05 in cross section 133.8 and SF=1.11 in cross section 134.1. These values do not provide a large safety margin, particularly

for the section 133.8. The destruction mechanisms for both profiles are shown in Figs. 10 and 11, in which orange and yellow colours represent the largest prognosed displacements.

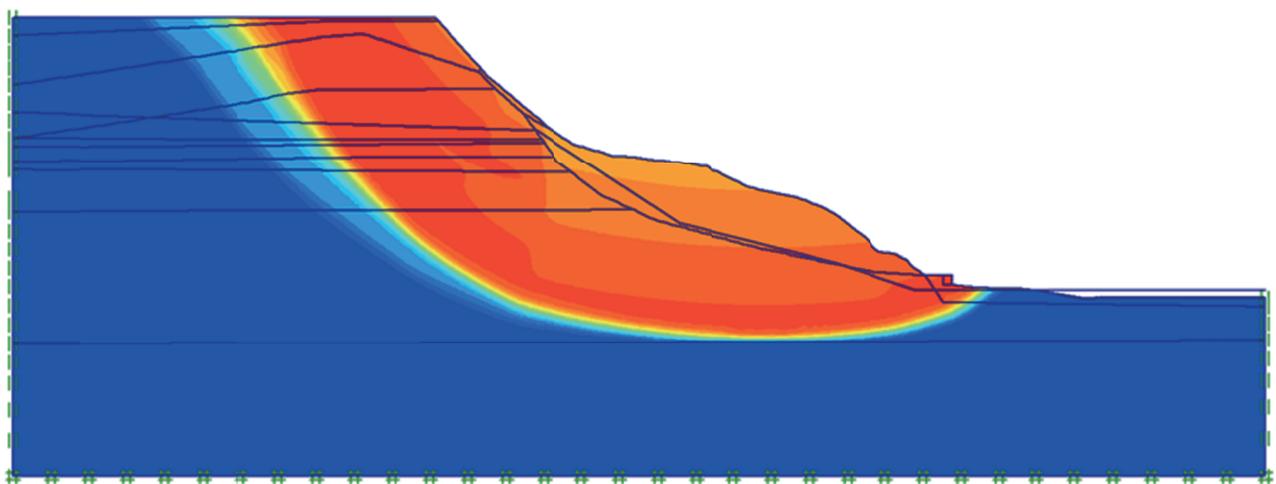
Fig.11. Global destruction mechanism (orange indicates failure) in cross section 134.1 (SF=1.11)

It is interesting to compare destruction mechanisms in cross section 134.1 for the current situation (Fig.11) and for the prognosed soil water table elevation by 2m (Fig.12). We can observe that the stability factor after water table rise decreased slightly, but in the former scenario we observe the global destruction mechanism, while in the latter case the local destruction mechanism is initiated.

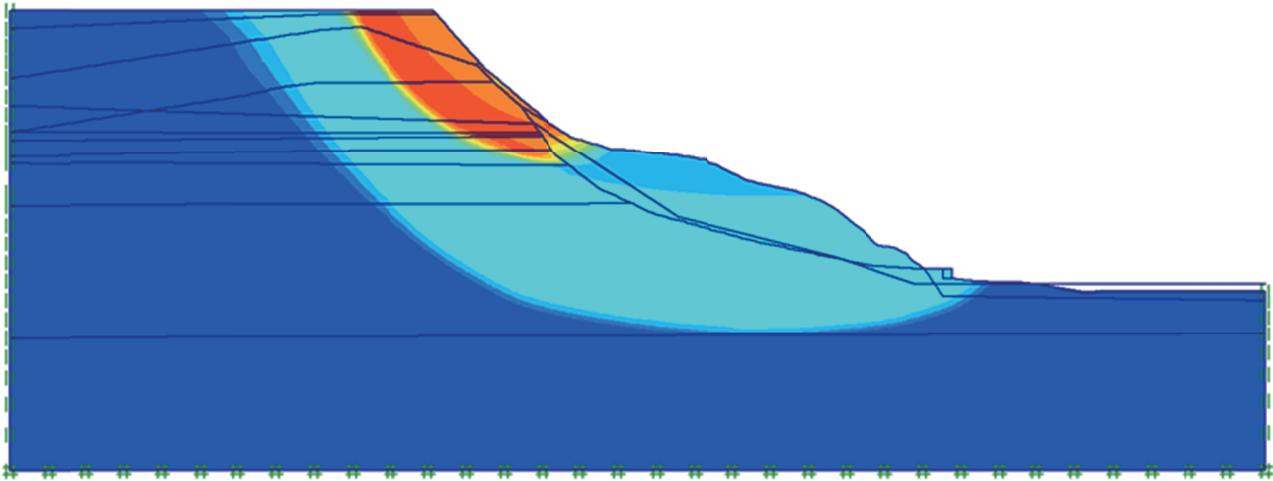
Fig.12. Local destruction with elevated water table (orange indicates failure) in cross section 134.1, SF=1.09

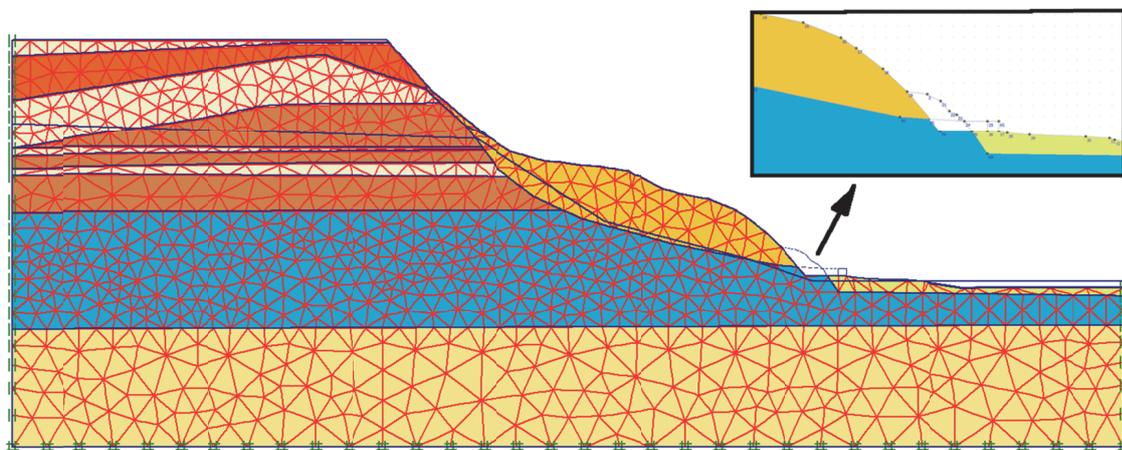
Fig.13. Cross section 134.1 with hypothetical damages caused by storm

Fig. 13 shows the simulation of after-storm conditions in which the cliff profile changed with respect to its current shape as a result of abrasion. This situation has been selected arbitrarily as a sample case from a variety of other calculated

possibilities. The stability calculations for the cliff geometry changed in the above way gave the result SF=1.09, i.e. slight reduction of the safety factor for this section. This means that in the case of real storm damages, we are able to assess, using numerical simulations, potential threat of stability loss at a given cliff segment and take appropriate measures.
