THE EFFECT OF FISHING BASIN CONSTRUCTION ON THE BEHAVIOUR OF A FOOTBRIDGE OVER THE PORT CHANNEL

Łukasz Pyrzowski
Mikołaj Miśkiewicz
Jacek Chróścielewski

Gdansk University of Technology, Faculty of Civil and Environmental Engineering

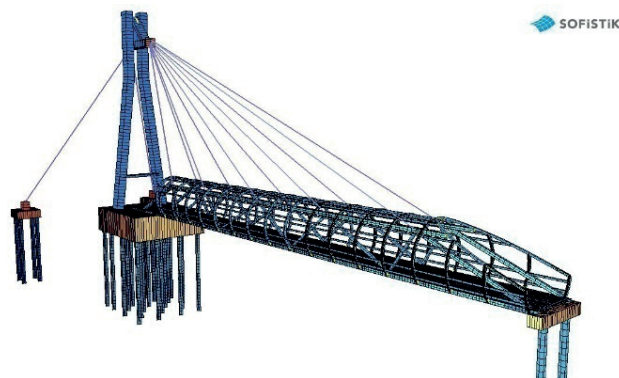
Computer simulations of the state of the structure were performed in the FEM environment within the linear-elastic range of material and the geometrically nonlinear range of the structure with imperfections [1,3,4,7,8,10,17,18]. In the adopted FEM models (Fig. 4) the following finite elements were used:

- 1-dimensional, 2-node spatial rod (beam) finite elements of Timoszenko type with eccentricity - used to model: pylon, grate, elliptic clamps, ribs and traverses of orthotropic platform plate, piles (8632 elements in the model);
- 2-dimensional, 4-node sheet elements of Timoszenko-Reissner type – used to model: the orthotropic platform plate (7627 elements in the model);
- 1-dimensional, 2-node spatial elements of rod-grate type – used to model: the footbridge structure suspension system (360 elements in the model).

Fig. 4. Visualisation of the FEM model used in the analysis
