## UNDERWATER WET REPAIR WELDING OF API 5L X65M PIPELINE STEEL

Gdansk University of Technology, Poland

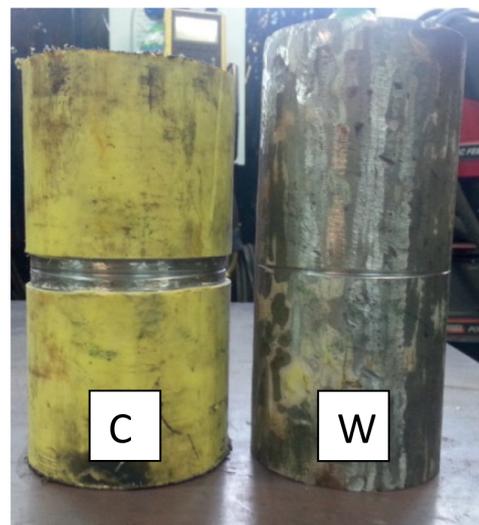
Fig. 1. Specimens prepared to welding. C – specimen covered with anticorrosive polymer coating; W – specimen without the coating.

For the experiments two pipe segments of the dimensions:  $\phi=102,9 \times 5,7 \times 250$  mm were taken from the water pressing pipeline installed at the underwater crude-oil field (Fig. 1). The specimen C was covered with an anticorrosive polymer coating of 2.5 mm in thickness. The specimen W had metallic surface after mechanical removal of the anticorrosive coating. Over 75% circumference of the pipes 1.5 mm-deep grooves simulating the repair - demanding defects (cracks, corrosive wear) on pipeline surface, were cut.
