# Capabilities to assess health/maintenance status of gas turbine blades with non-destructive methods

Józef Błachnio, Prof.

Air Force Institute of Technology, Warsaw, Poland

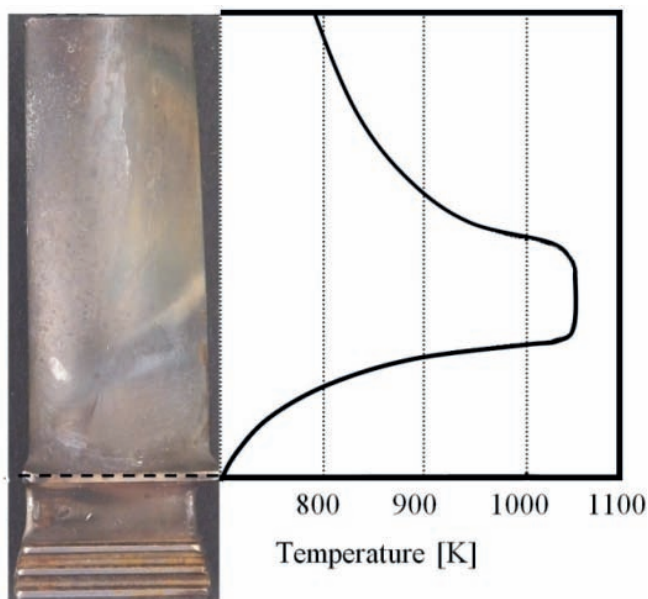
Fig. 2. A diagram of the typical temperature distribution along the gas turbine blade feather [5]

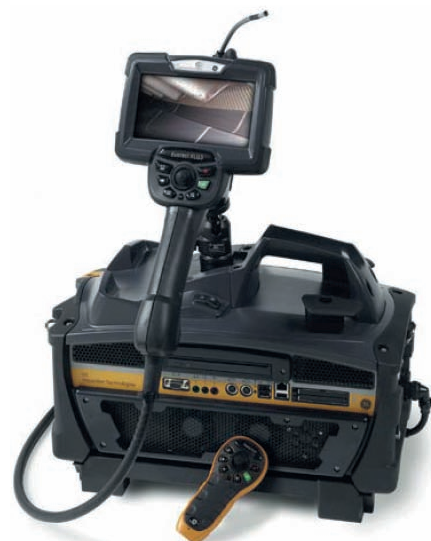
Fig. 3. Optoelectronic device – videoscope [11]

[2, 13]. In the case of the use of optical instruments, and in particular a videoscope, it is possible to inspect the object without necessity of disassembling it. The acquisition and development of information that could be useful for the diagnosis of machine parts, is a complex process that requires multiple treatments. In general this process can be summarized as follows [3, 6]:

Illuminated surface of the blade can be recognized by a light-sensitive detector (CCD matrix with an optical system – optoelectronic system) through a secondary source of light from its surface. CCD matrix counts incident photons, energy of the light rays incident on each pixel. In the case of a computer vision system the image is obtained from ambient by means of an optoelectronic device – videoscope (Fig. 3). This enables indirect method of diagnosis of the object through the processing and analysis of data collected in the form of digital images.

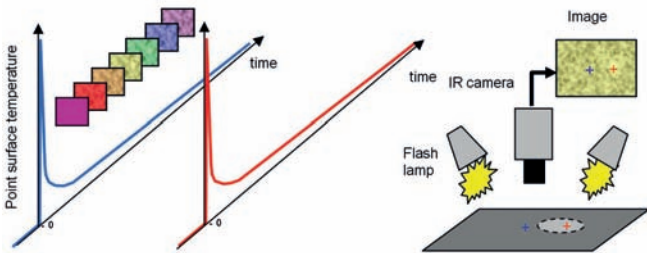
Fig. 6. Diagram to explain the application of pulse thermography [23]

The occurrence of defects in the material reduces the diffusion rate which means that temperature of the surface area above the defect will be different from the temperature of the region under which there are no defects – and therefore, the aspect of the above relationship changes. This method (as well as others), has limitations, due to rapidly fading with depth the temperature contrast it only allows for the detection of subsurface flaws.

Active thermography is based on the detection of infrared radiation. The essence of the study is to analyze the thermal response of the material to external impulse heat stimulation. If a certain amount of energy is delivered to the surface of the material, for example in the form of a heat pulse, after its expiry the surface temperature will start changing rapidly. Due to thermal diffusion, thermal front will move into the material. The presence of areas with different thermal properties (including defects) compared with areas without defects causes a change in the diffusion rate. Thus, by monitoring the temperature field on the surface of the cooling sample, it is possible to reveal position of the defects. Depending on the stimulation method, there are a few types of active thermography, namely, pulsed thermography, lock-in thermography with modulated heating and pulsed phase thermography [12, 17]. Pulsed thermography is considered to be a relatively simple kind of active thermography. It depends on the determination and analysis of the temperature distribution in the study area during its cooling down after prior uniform heating with the use of thermal pulse (Fig. 6).

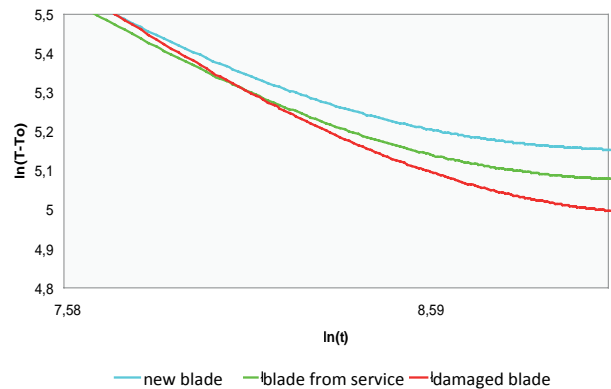
Thermal response of blade surface to heat pulse

Fig. 7. Blades thermograph and changes of dependence of the parameter  $\ln(T-T_0)$  of the thermographic signal at selected points of the blade surfaces [14]

Thermographic examinations covered the turbine blades made of alloy EL-867WD, classified into various categories: new, used - fit and damaged during turbine engine operation. The obtained results confirmed changes of parameter dependence of thermal response of the examined blade materials to stimulating heat pulse (Fig. 7).

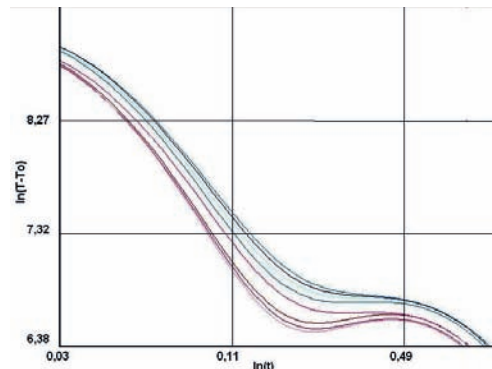
Fig. 8. View of exploited blades I and V categories and chart of their material response for the heat pulse [14]

Subsequently, by means of active pulsed thermography examinations of operated gas turbine blades were performed. The research was carried on the rim steering blades of gas turbine aircraft jet engine made of an alloy ŽS-6K. Based on visual criteria of assessment, the blades were classified into various groups according to their degree of overheating (category I to V). The result of research affirmed that the thermal response of the blades material considered as “able”

(category I) is uniform over the entire surface (Fig. 8). While on the basis of the analysis of the response to the heat pulse of the blade material classified as “unfit” it was possible to determine clearly deviating from the average value of the zone. These areas coincide with areas visually assessed as overheated which, together with the results of the tests conducted on samples (Fig. 7) gives rise to the inference of superheated material structure.

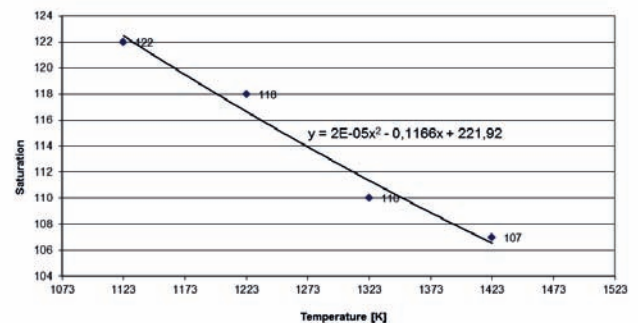
Fig. 5. The values of the position of the maximum amplitude of grayscale saturation of blade surfaces annealed in conditions similar to realistic [3]

Acquisition by videoscope and computer analysis of images of the surface samples of the blades made of superalloy EI-867WD were performed before and after heating in a furnace in realistic conditions. Studies of the first order statistics (parametric description of histograms) of images of blades surfaces showed a monotonic decrease of values of the amplitude of grayscale saturation (Fig. 5).
