DEGRADATION OF THE CONCRETE RAILWAY TRACK BED LOCATED IN THE VICINITY OF THE LOADING WHARF

Maciej Niedostatkiewicz

Gdańsk University of Technology, Faculty of Civil and Environmental Engineering, Poland

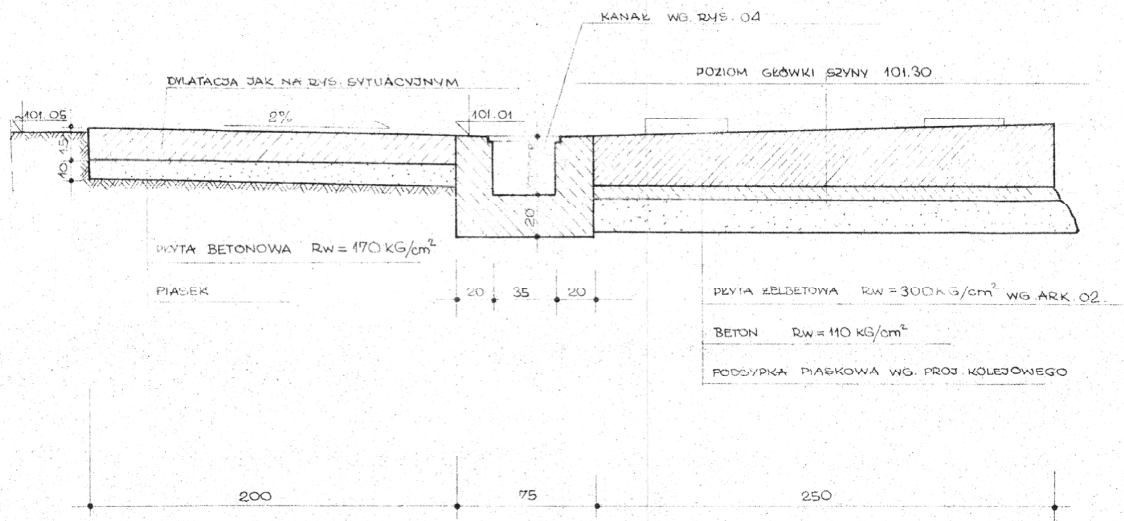
Fig. 1. The design solution of the concrete railway subgrade-cross-section (based on archival project documentation)

The 100 m long reinforced concrete track bed was located in the vicinity of the wharf and used for loading and unloading petroleum materials for rail tankers. The railway track was laid on a reinforced concrete track bed. The plate consists of three elements: the main part of the track bed, the drainage channel and the sewage tray (Fig.1 and Fig.2).
