Management of liquid wastes on floating docks in the aspect of its impact on the environment

Piotr Marcinowski, D.Sc., Eng.
Joanna Biernacka, M.Sc., Eng.
Maria Olesiejuk-Kowalska, M.Sc., Eng.
Warsaw University of Technology

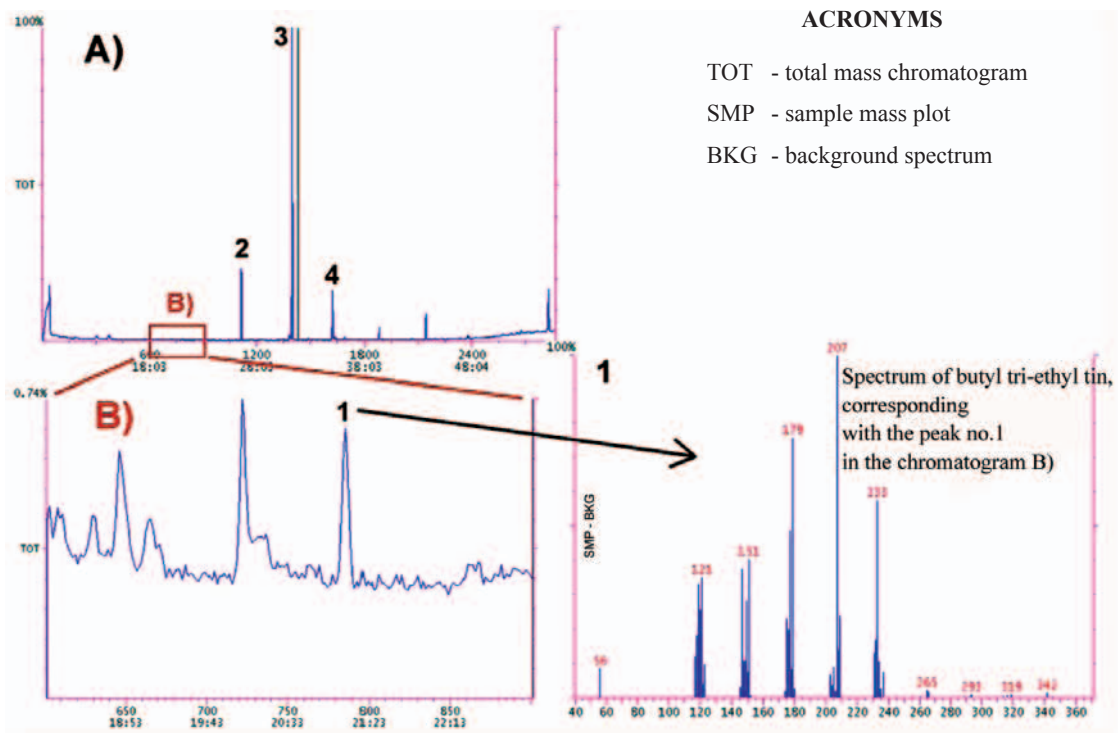
Fig. 5. Examples of chromatograms showing spectra of organic tin compounds found in a sample of filtered waste water.
