CONCEPT OF COMPUTER-AIDED ASSESSMENT OF THE TECHNICAL CONDITION OF OPERATED GAS TURBINE VANES

The article presents a multi-stage algorithm for automatic (without any human, user – diagnostician intervention) detection of vanes-blades (technical objects) and their surfaces on a digital image, combined with color analysis, aimed at determining the technical condition of the tested turbine elements. The images recorded with the use of a camera, containing previously dismantled from the turbine operated stator vanes, were used as the exemplary analysis material. The paper presents the algorithm for the detection of the vanes' airfoil surfaces with the impact of the applied techniques and methods of image processing and analysis on the final result (software localization of the vane's trailing and leading edge). Then, the obtained image data, including the structural changes of both the vane's coating and material (metallographic testing) were correlated with the surface colour scheme (colour segmentation based on the YCbCr colour space model). Thanks to this approach, areas on the surface of the blade were distinguished, characteristic for proper, overheated and transient condition.

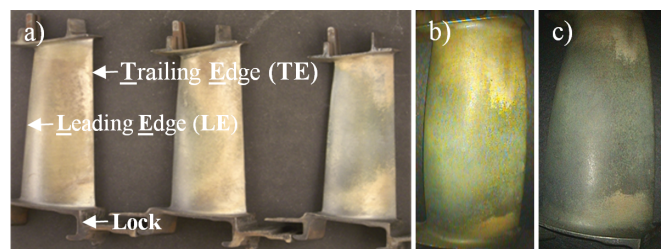
Fig. 1. Changes in vane surface colour recorded using various devices:
a) image recorded at the measurement station using a camera;
b) image recorded using the Olympus Iplex SA II videoscope;
c) image recorded using the Everest XLG3™ VideoProbe videoscope

The input images included photos of guide vanes disassembled from a gas turbine of an aircraft jet motor (Fig. 1). The vanes were made from the ŽS-6K alloy. An important technological aspect in these type of alloys is the thermal processing, which is based mainly on homogenising annealing (unification of the structure, increase in strength and ductility) [20]. The purpose of the processing is also obtaining the adequate dispersion and shape of precipitation of phase γ' as the main reinforcement phase. The coating is applying to allow increasing the working temperature, thereby additionally protecting the base material against harmful impact of the high temperature working medium (exhaust fumes). Figure 1a presents an exemplary set of recorded images of turbine vane surfaces with various degrees of overheating (acc. to the currently applied classification of their technical condition) with marked trailing and leading edges.

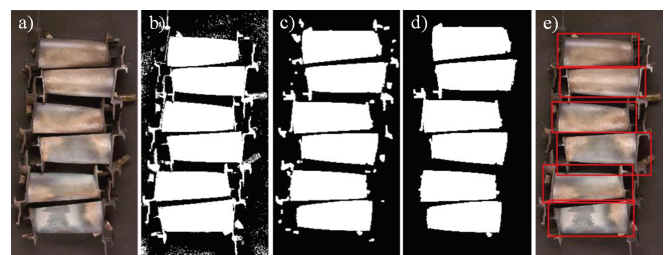
Fig. 3. Subsequent stages of vane detection on the recorded digital image: a) example of the original image; b) initial binarisation; c) opening operation; d) reduction of small objects; e) correct detection of the turbine vane surfaces

The initial binarisation allows for separating the object pixels from the background pixels, however using it caused a large number of artefacts to be left on the binary image (Fig. 3b). They were removed by using the morphological function of binary image opening (with the structural element in the form of a disk with the size of 10 pixels); the effects of this operation are presented in figure 3c. An additional advantage of executing the opening operation will be the separation of possibly combined or interfacing vane surfaces. The next step featured the indexation (labelling) of objects (vanes), thereby reducing the number of small objects that did not belong to the vane leaf's surface (mainly elements of the vane's lock) – Fig. 3d. As result of the executed operations (Fig. 3c and d), most artefacts, left from image binarisation (Fig. 3b), were removed, thereby preventing their impact on the dimensions of the designated surfaces (Fig. 3e). In figure 3e, the red colour was used to mark the smallest rectangles that completely surrounded particular detected objects (bounding box).

Due to the fact that the vanes in the digital image can be positioned in any configuration (position, number), the detected objects – surfaces (each rectangle from Fig. 3e is a new image cut from the original image in Fig. 3a) must be placed (positioned) in the same way (identical position of TE and LE).

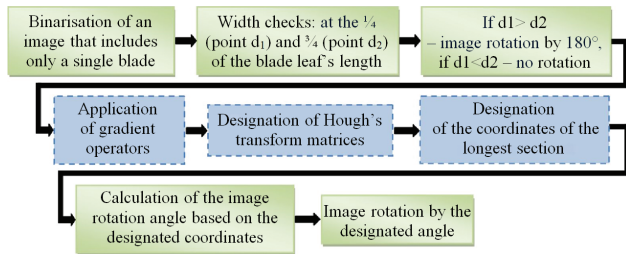
Fig. 4. Algorithm of automatic rotation of the vane surface with an isolated (blocks marked with a dotted line) procedure of section detection in the image

Therefore, the image fragments that include the detected surfaces were rotated, depending on the vane's position, by a suitable (designated) angle, thereby bringing all of them to a common reference frame. The general algorithm of automatic rotation is presented in Fig. 4. The position of the TE and LE for each vane was checked in the first step. Then, certain (selected) geometric features of the tested turbine elements were used to check the width at two positions: at 1/4 and 3/4 of the vane leaf's length (Fig. 5a). The dimensions comparison operation was executed on a binarised image fragment (Fig. 5b) – the sum of the values is designated in the right (dimension d2) and left (dimension d1) column. If $d2 < d1$, the entire image is rotated by 180°. Thus, we obtained images on which vanes are positioned as assumed, i.e. TE upwards.

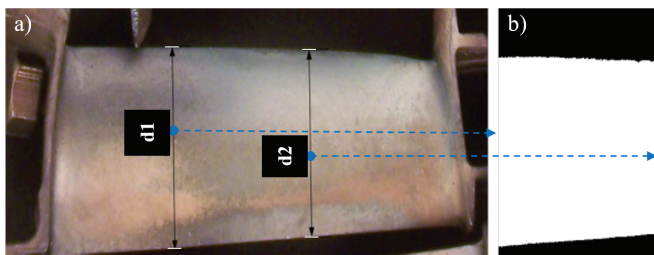
Fig. 5. Example of determination of differences in the vanes' geometry: a) compared vane dimensions; b) the binary image presents the difference in the vane's width (dimension d1, d2)

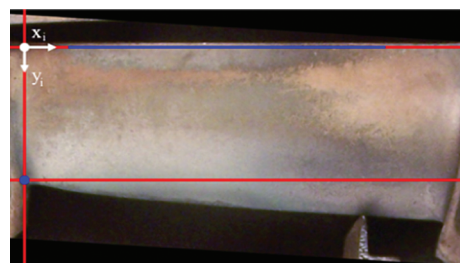
Fig. 7. Lines limiting the vane surfaces – sought (rectangular) area for further colour analysis

After changing the vanes' configuration and rotation, we obtained images on which the vanes are positioned in an identical way. Then, while maintaining only the vane surface pixels (without the background pixels), it was necessary to cut the rectangles with the largest area possible from the images. Due to the fact that all fraction points were to be located within the area of the vane surfaces, we conducted an image binarisation with the threshold selected using the iteration method. Then, we used the morphological erosion method (with a square structural element with a 20 pixel size, thereby "reducing" the vane's surface) on the binary image. This operation allowed for further application of the gradient (Sobel's) operators and Hough's transform in order to designate the coordinates of two points belonging to the top (position of the edge on the photo) vane edge (blue section in Fig. 7).

Thus, we were able to designate the straight line limiting the area later cut from the image for further analysis from the top (top red straight line in Fig. 7). The applied steps of

This was also the reason for the calculation for the binary image of the sum in the image matrix columns (the vane area is white in the binary image – it has the value “1” in the image matrix), by selecting the column with the lowest sum value, we designated the position on the vane’s length on which it has the smallest width. Thus, we obtained the straight line that limits the sought area from the left (red straight line on the left in Fig. 7). The bottom limitation of the sought image (bottom red straight line in Fig. 7) was obtained by locating in the earlier designated column of the last one, i.e. last column point belonging to the vane surface (from the top of the photo, blue point in Fig. 7).

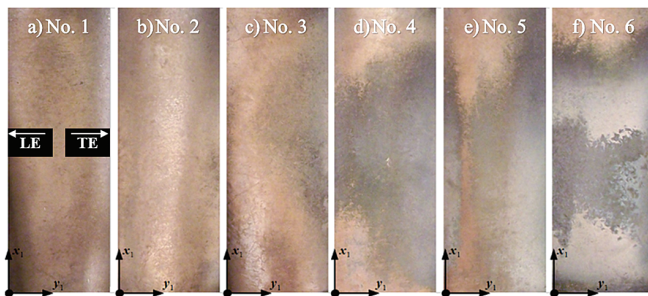
Fig. 8. Separated vane surface areas (various technical condition a-f)

The separated vane surface areas (Fig. 8a-f) with various technical condition will undergo colour analysis correlated with the micro-structure testing both in the sub-surface zone and material of the vane and the coating.

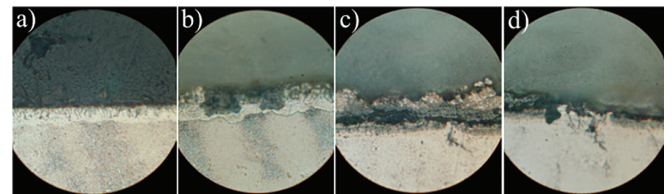
Fig. 9. Micro-structure of the coating of used polycrystalline turbine vanes (ZS-6K alloy), x450 zoom

After analysing the technical condition of the coatings of used vanes from a turbine’s jet crown (Fig. 9), it was established that after some time of operation the vane’s coating does not degrade (Fig. 9a – vane no. 1 of fig. 8a) and its thickness does not differ from the thickness of a new vane’s coating. This condition of the coating is characterised by lack of any damage. After a longer time of operation, the coating undergoes expansion and features local surface damage (Fig. 9b – the condition was observed incidentally on vane no. 3 from figure 8c, its share increases in vanes no. 4, 5, 6). This condition of the coating is classified as partially fit for further use.

The expansion of the coating causes its delamination and cracking in the latter period of operation (Fig. 9c – the condition was incidentally observed on the leading edge of vane no. 5 from figure 8e, while the biggest share of the condition was ascertained in vane no. 6 from figure 8f). This type of damage causes local separation of the surface layer and cracking of the transitional layer diffused into the native material of the vane. In effect, within a short time of operation, the surface layer comes off and the crack penetrates deep into the vane's super alloy (Fig. 9d – vane no. 6 from figure 8f, mainly the area affected by the highest temperature, i.e. 1/3 height of the vane's leaf). Damage in the form of coating delamination, local cavities in the surface layer and development of cracks result in its classification as an element that is unfit for further use. In the case of the vane material's micro-structure, it was ascertained that vane no. 6 is characterised by dispersive secondary separation of the phase γ' , resulting from the impact of high temperature exhaust fumes. The morphology of phase γ' indicates that after exceeding the critical temperature, the alloy is overheated, and the turbine vane cannot be deemed as fit for further use [4, 23, 24].

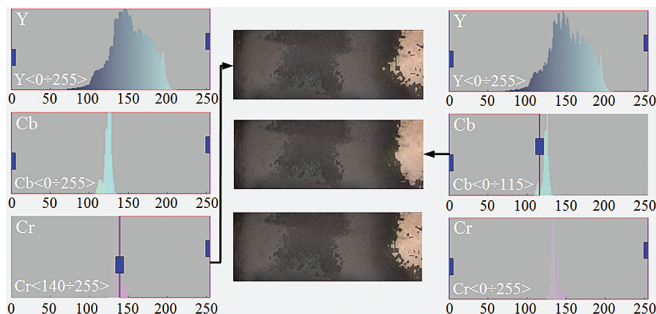
Fig. 11. Example of coloured surface segmentation of used vane marked as no. 6 (Fig. 9f): a) histograms of particular constituents of the YCbCr model (with a marked limitation of the range of constituent Cr); b) result of segmentation (with emphasis on the non-overheated area – reduction of range Cr); c) histograms of particular constituents of the YCbCr model (with a marked limitation of the range of constituent Cb); d) result of segmentation (with emphasis on the non-overheated area) e) result of segmentation (double limitation of Cb, Cr)

Based on the values of constituents Cb, Cr for vane no. 1 and the nature of the waveform of these constituents in the colour profiles of vane no. 6, we designated the threshold values describing the non-overheated surface. The threshold value was designated for constituent Cr in the range from 140 to the maximum value, i.e. 255 (the other two constituents were not limited) – Fig. 11a

The result of the surface segmentation of vane no. 6 with limitation of constituent Cr is presented in figure 11b (the area differing from the correct surface was dimmed by applying an operator). On the other hand, the range of the constituent Cb was modified in figure 11c (value range from 0 to 115). The result of the segmentation (limitation of the range of constituent Cb) and marking of the overheated area

is presented in figure 11d. On the other hand, figure 11e presents the resulting image with two limitations of the range of constituents Cb, Cr.

The surface with the correct condition in the case of vane no. 6: Fig. 11b amounts to 11.34% of the total surface, Fig. 11d – 9.89%, Fig. 11e – 9.02% (double limitation slightly changes the percentage share of the surface).

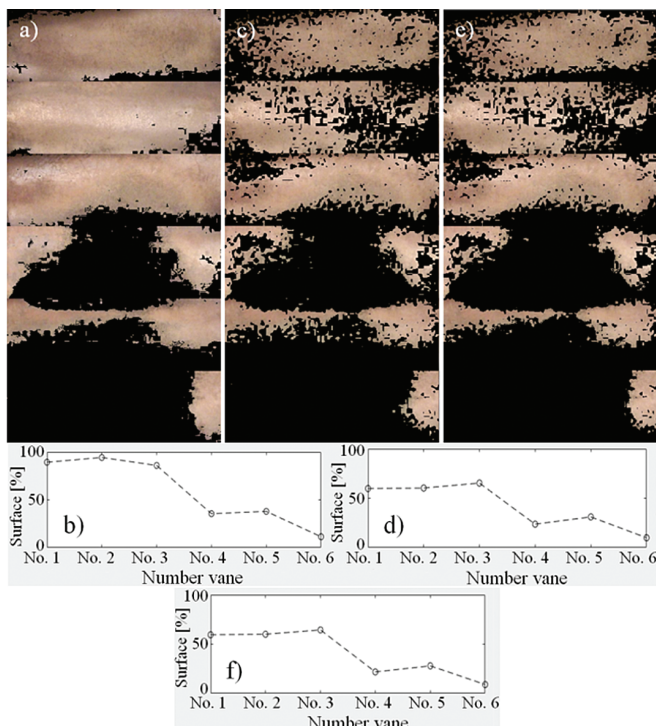
Fig. 12. Results of segmentation of the exemplary set of vanes (Fig. 8, no. 1÷no. 6): a) surface images and b) percentage share of surfaces classified as satisfactory with the reduction of the range of constituent Cr; c) surface images and d) percentage share of surfaces classified as satisfactory with the reduction of the range of constituent Cb; e) surface images and f) percentage share of surfaces classified as satisfactory with the reduction of the range of constituents Cb and Cr

Figures 12a, c, e present the results of segmentation, including the surface classified as satisfactory for the exemplary set of vanes from figure 8.

Nearly identical results apply to figures 12d and 12f. The value fluctuations do not exceed 0.3%, whereas the largest difference of 4.03 % applies to vane no. 5 (12d – 27%, 12f – 31.03%). The differences in figures 12a, c, e result both from the colour scheme of the tested surfaces (vane no. 1, 2 “shades of yellow”) and from the adopted method of determining the threshold values (average). The largest percentage share of surfaces classified as satisfactory, for particular vane numbers, was obtained with the limitation of constituent Cr (no. 1 – 91.3%, no. 2 – 94.25%, no. 3 – 85.93%, no. 4 – 35.54%, no. 5 – 37.94%, no. 6 – 11.34%) – Fig. 12b. The area that does not belong to the surface classified as satisfactory (black) also features the surface in transition (between satisfactory surface and overheated surface). It is characterised by a certain ambiguity due to the condition of the coating, the thickness of which increased (swelling of the surface layer and transitional layer), but the average thickness, due to the existence corrosion and erosion pitting, is lower than in the case of vanes no. 1, 2, but higher than in vane no. 6 (Fig. 9b). The structure (size, shape and distribution of separations of phase γ') deep into the vane material, only in extreme cases, at the transitional layer, slightly deviates from the model structure. The colour scheme of this surface is characterised by a different colour. Based on the metallographic testing combined with a colour analysis of the discussed type of surfaces, we determined the threshold values of segmentation for particular constituents, i.e. $Y < 58.160 >$, $Cb < 112.119 >$, $Cr < 0.138 >$. The result of the segmentation is presented in figure 13a (orange – areas of surface in transition).

The paper proposes the concept of computer-aided, non-invasive method of assessment of the condition of operated vanes (blades) based on the colour of their surface. The described approach embraces several stages. The first stage concerns the detection of the surface (strictly determined and related to the area of the blade's leaf), which is then subjected to colour analysis in the next stage. The first stage concerns the detection of the surface (strictly determined and related to the area of the vane's leaf), which is then subjected to colour analysis in the next stage. The verification of the technical condition of used vanes was conducted using a destructive method on metallographic samples. The metallographic testing concerned the assessment of the coating's condition and the characteristics of the separation of phase γ' (both in the vane's surface layer and in its material). The material criterion was correlated with the colouristic changes on the vanes' surface. Based on the colour profiles, we were able to determine the threshold values describing particular colour ranges (histograms of constituents of the YCbCr model) representing an overheated, non-overheated vane and vane in transition. The most satisfactory results were obtained in the case of determining the range of values for constituent Cb (the determined range of constituent Cb includes the largest colouristic differentiation of the tested surfaces with simultaneous maintenance of the correctness of the obtained results – this thesis was confirmed by metallographic testing). Based on the results of the analysis of the vane surface images, it is possible to conclude that vanes no. 1, 2 and 3 are satisfactory, because the percentage share of the surface classified as satisfactory and in transition (with minimum share of this condition amounting to 3.25%, 2.5%, 6.25%, respectively) fluctuates around 95% (Fig. 13c). On the other hand, vanes no. 4, 5, 6 are overheated, because the percentage share of the overheated surface and surface in transition (in the case of vanes no. 4 and 5, with a substantial percentage share amounting to 13.87% and 16.5%) substantially differs from the aforementioned vanes, and the overheated surface for particular vanes is as follows: no. 4 – over 50%, no. 5 – over 45%, no. 6 – over 80% (Fig. 12a, 13b, c).

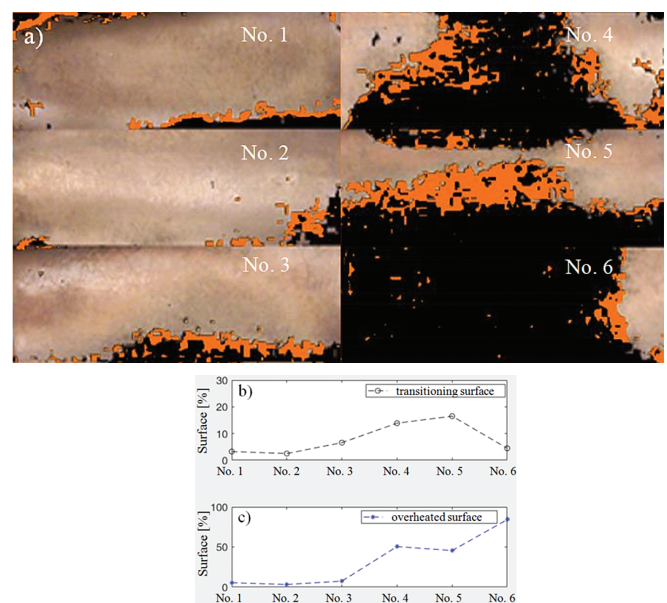
Fig. 13. a) images of the surface of used vanes no. 1÷no. 6 (orange – transition); b) percentage share of these surfaces; c) percentage share of overheated surfaces

The share of surfaces in transition does not exceed (vanes no. 1÷no. 6) 20% (Fig. 13b). The highest share concerns vane no. 5 and amounts to 16.5%, whereas for vanes no. 1 and no. 2, the share is miniscule and amounts to 3.25% and 2.5%, respectively. A similarly low value applies to vane no. 6 (4.1%). Figure 13c presents the share of the area (surface), the condition of which deviates from the satisfactory condition (the share of the surface in transition was also taken into consideration).
