# Results of acoustic emission tests of corrosion protection degree of ship steel tanks covered by means of protective coatings (Phase I)

Henryk Bugłacki  
Piotr Eichert  
Gdańsk University of Technology

*This paper presents methods and results of the 1<sup>st</sup> series of tests of acoustic emission (AE) signals, aimed at assessing degree of corrosion protection of a tank made of hull structural steel, protected by means of a protective coating combined from polyurethane layer and concrete filler. The tests were carried out in compliance with a method specially elaborated for application to the work in question. In the method were used requirements of the standards in force, as well as experience gained during realization of the research project CORRSHIP, included in 5<sup>th</sup> Frame Program of European Union. The application of the AE method to detect and localize corrosion sources during exposure of specimens to corrosive mixture confirmed its high usefulness for the carried-out tests on corrosion protection effectiveness of new types of protective coatings.*

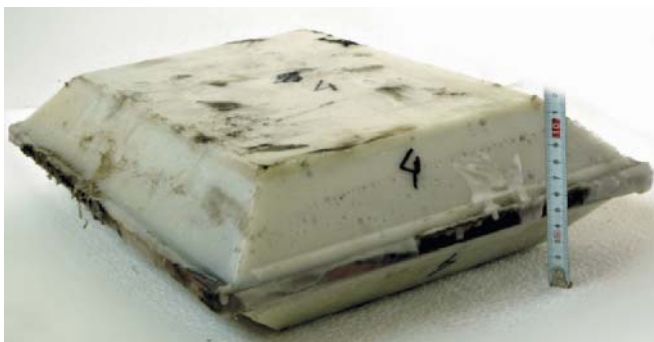
Fig. 2. The specimen covered with the polyurethane layer - concrete filler protective system

In Fig. 2 the specimen covered with the polyurethane layer - concrete filler protective system is shown.

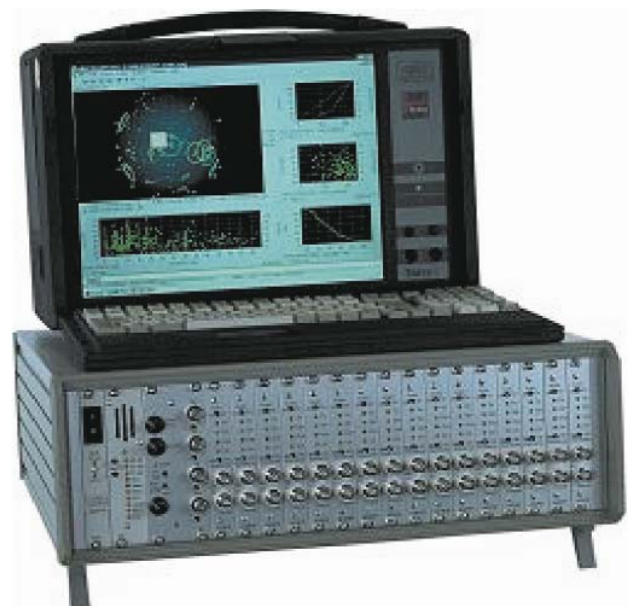
Fig. 4. AMSY5 system of the Vallen firm applicable to AE testing.

For measurements the 16-channel set of AMSY5 system and VS30-V, VS75-V sensors of the firm Vallen Systeme GmbH (Fig. 4) were used.

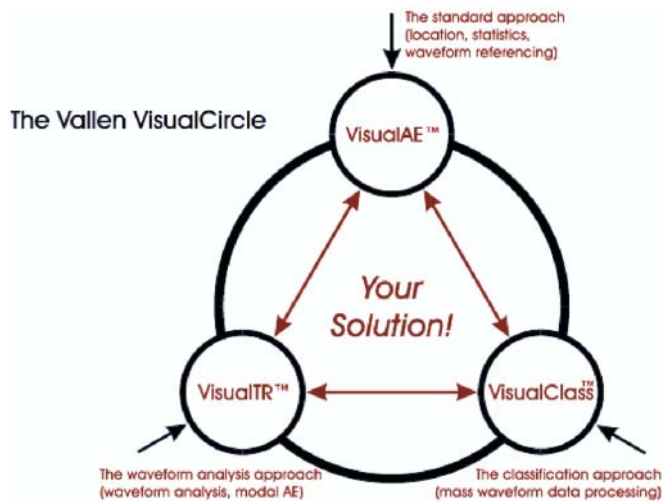
Fig. 5. The software for AE signal recording and analyzing, of the Vallen firm [8]

To record AE signals and to analyze them a special software of the Vallen firm was used (Fig. 5) [8].

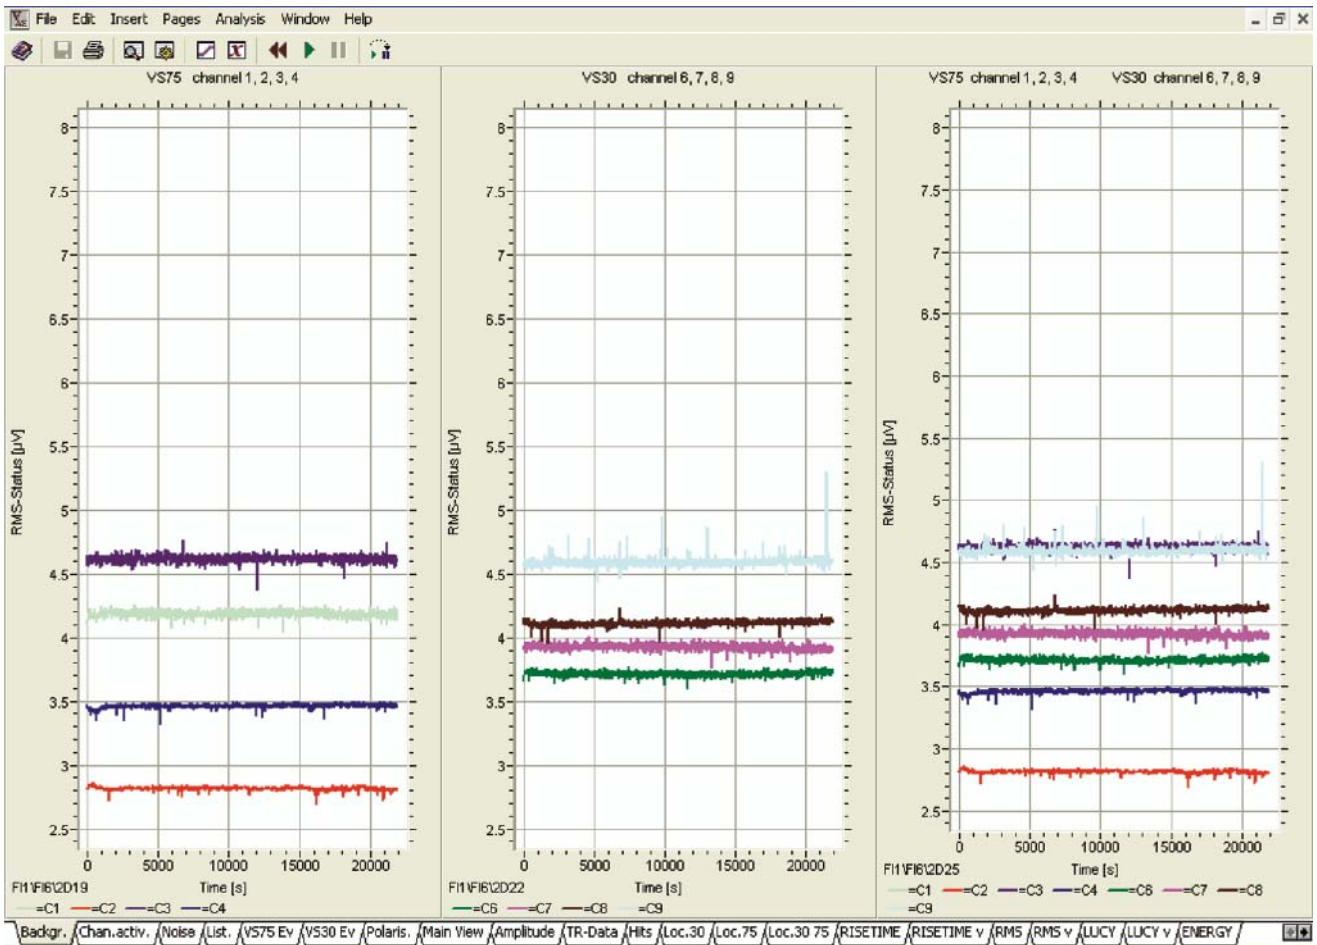
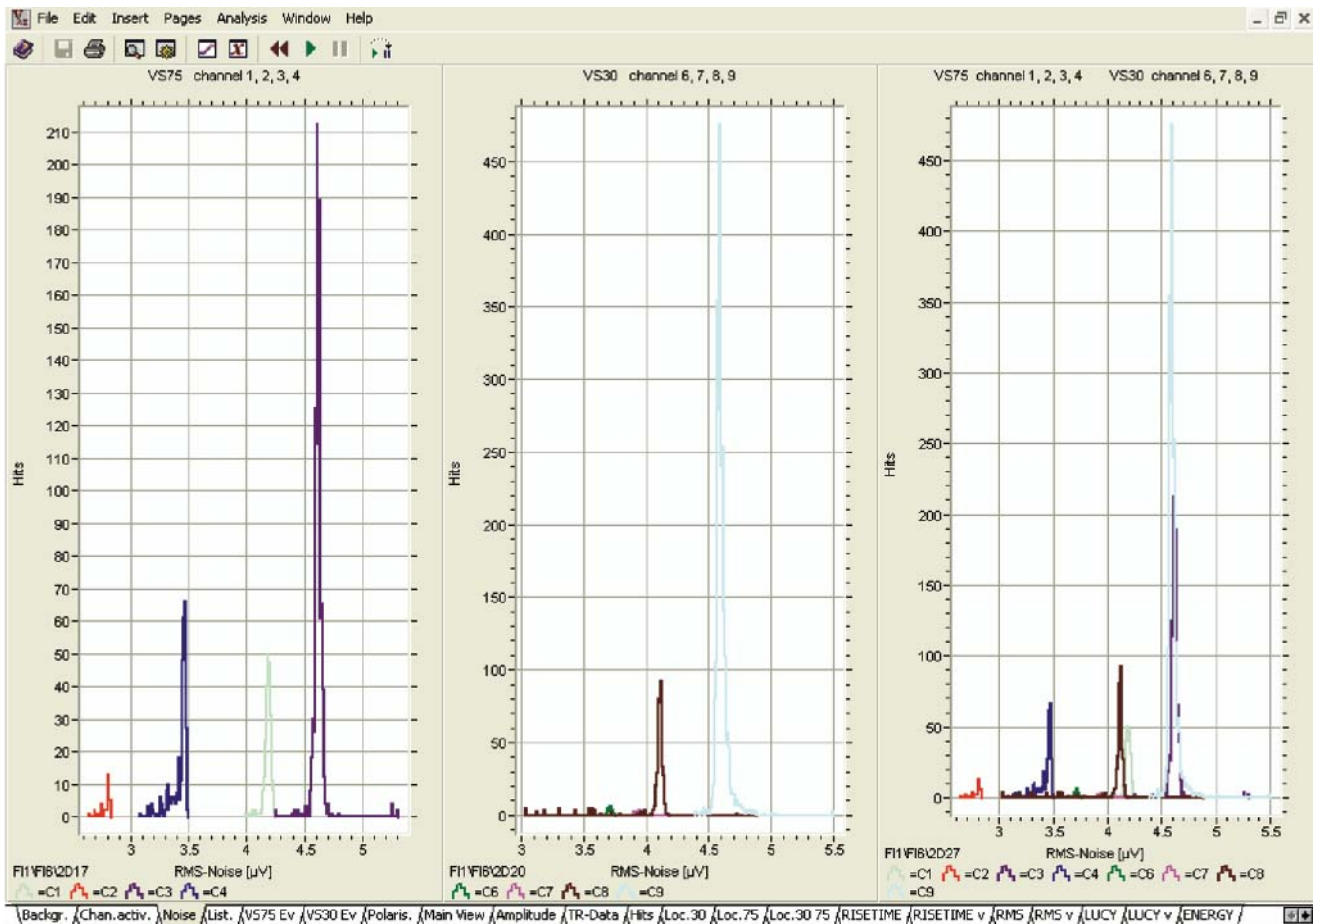
a) The mean intensity of AE signals (background) – the background  $U_{RMS}$

Fig. 7. Example AE signals and descriptors recorded for the selected test no. 19 performed for the whole set of plate specimens

The example recorded AE signals and descriptors for the selected test no. 19 of the entire set of specimens, are presented in Fig. 7. The raw plate specimen (S) showing a significant level of AE signals has been correctly localized. The plate specimen no. 7 covered with the paint coating shows weak AE signals. Additional weak sources of AE signals, located on the plate specimen no. 6 covered with the polyurethane layer-concrete filler coating, were also found. As the AE signals localized in it are characterized by another quantity of energy and another rise time it can be deemed that the source of AE signals is of a different character than corrosive one. It can be e.g. processes which occur within internal structure of the concrete filler.

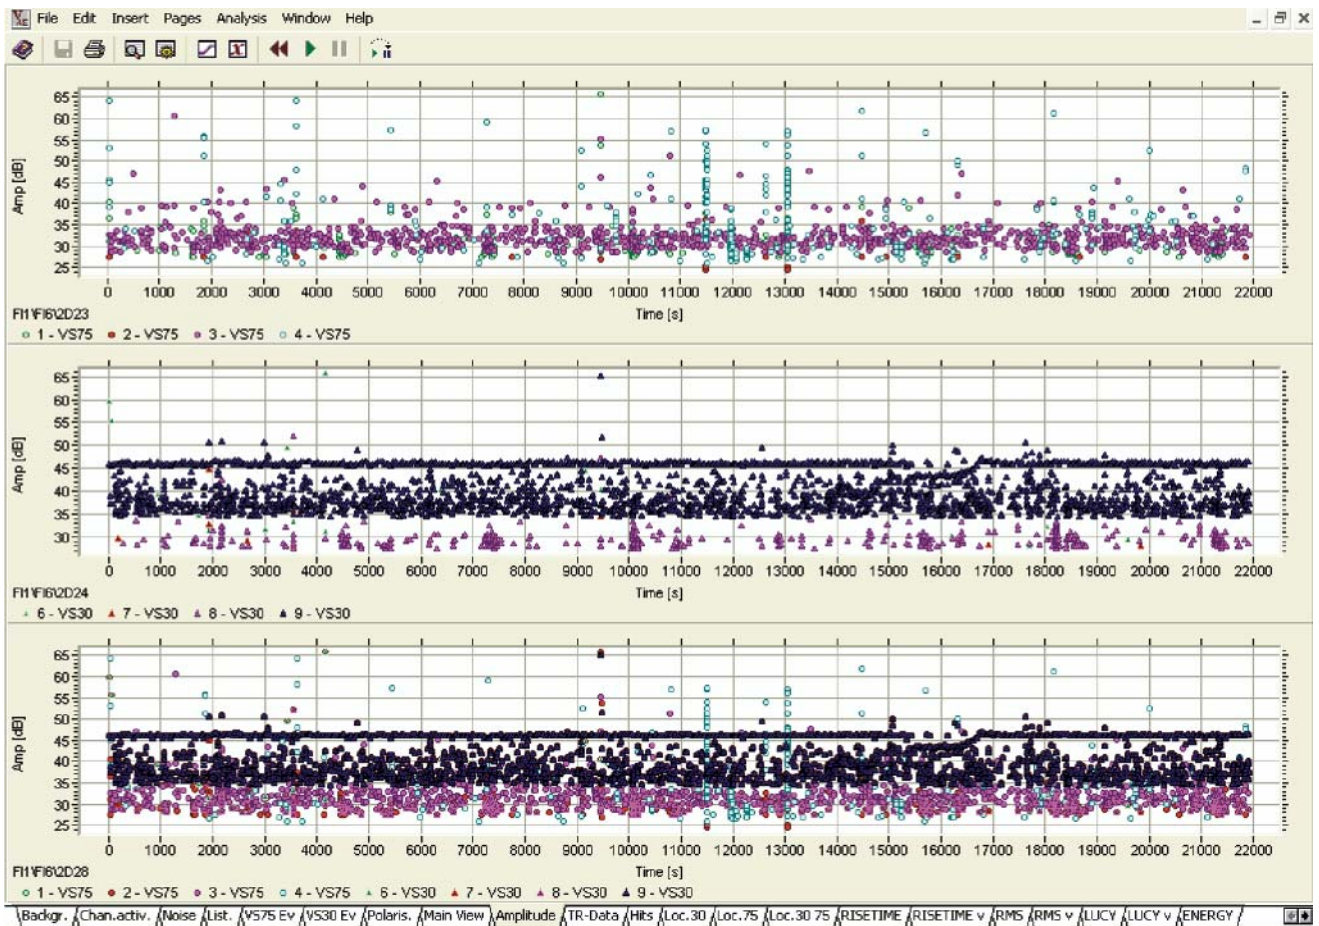
c) The peak amplitude  $A_m$

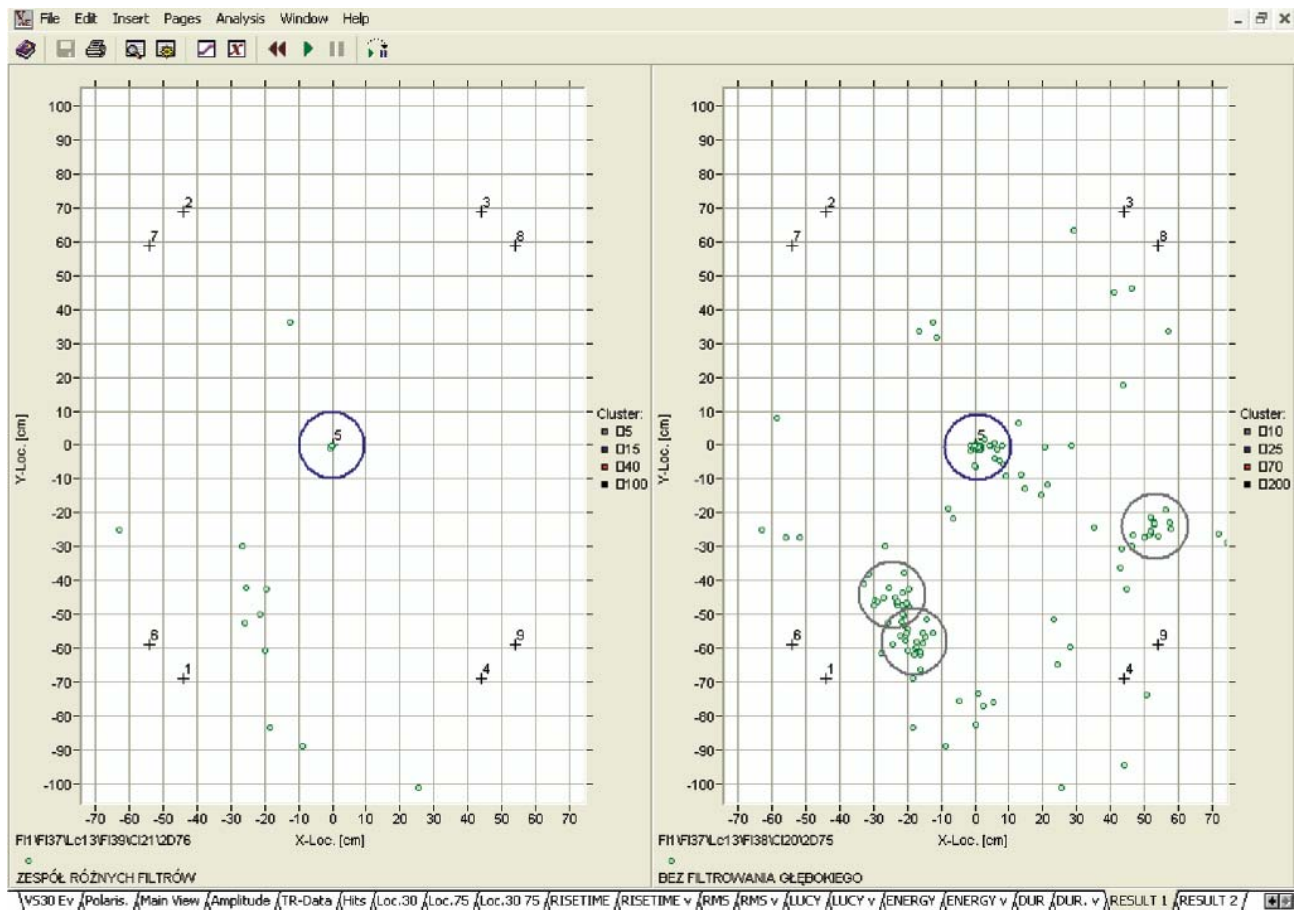
d) Localization without filtering
