POLISH MARITIME RESEARCH 4 (104) 2019 Vol. 26; pp. 142-148 10.2478/pomr-2019-0076

# COMPARATIVE STUDIES OF THE SEATINGS OF PROPULSION PLANTS AND AUXILIARY MACHINERY ON CHOCKS MADE OF METAL AND CAST OF RESIN PART I. MOUNTING ON STEEL CHOCKS

Paweł Grudziński Konrad Konowalski Zachodniopomorski Uniwersytet Technologiczny w Szczecinie, Poland

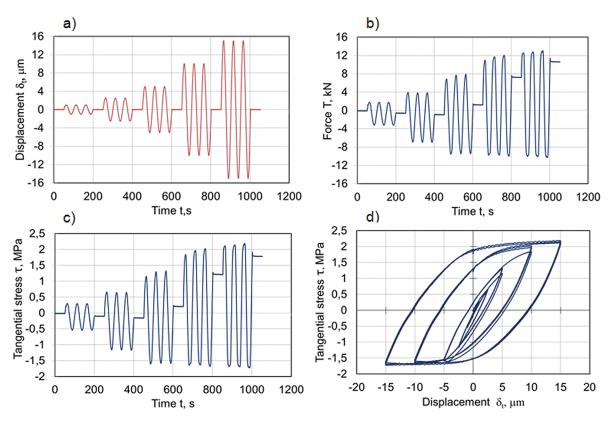
Fig. 7. Results of experiment 2: (a) time evolution of the implemented relative displacements of the connected elements using the testing machine; (b) time evolution of the force T used to realise the displacements; (c) time evolution of the average shear stresses acting on the chock; and (d) relationships between the stresses τ and displacements δ.

The task of the testing machine equipped with the program for dynamic research was to provide an adequate time period for loading, which would ensure the implementation of the assumed oscillations shown in Fig. 6b. Figure 7 shows the results of this experiment.

These graphs show (a) the time evolution of the oscillations (the relative displacements  $\delta_{t}(t)$  of the connected elements measured at points 1 and 2) performed by the testing machine; (b) the time evolution of the force T(t) used to realise the assumed displacements; (c) the time evolution of the average shear stresses  $\tau(t)$  acting on the chock; and (d) the relationships between the stresses  $\tau$  and displacements  $\delta$ , and the hysteresis loops for the selected oscillation amplitudes shown in Fig. 7a. The high accuracy of the sinusoidal displacements (oscillations), with very small amplitudes (from 1 to 15 µm), and the irregular complex time evolution of the force needed for their implementation should be noted. The hysteresis loops (Fig. 7d) show that the system behaves quasi-linearly only at sufficiently small displacement amplitudes (max. 5 µm). At higher oscillation amplitudes in the tangential direction, substantial micro-slips and large hysteresis loops are clearly visible. This shows the loss of the elastic integrity of the tested joint and the dissipation of a large amount of vibration energy.

A positive effect of this phenomenon is good vibration damping, and a negative result is the intensive wear of the interacting surfaces, which leads to rapid destruction of the joint. In well-designed bolted joints, significant micro-slipping should not take place. One important issue is to establish a reasonable limit for micro-displacements at a contact that allows for safe long-term operation of the bolted joints loaded by variable tangential forces.

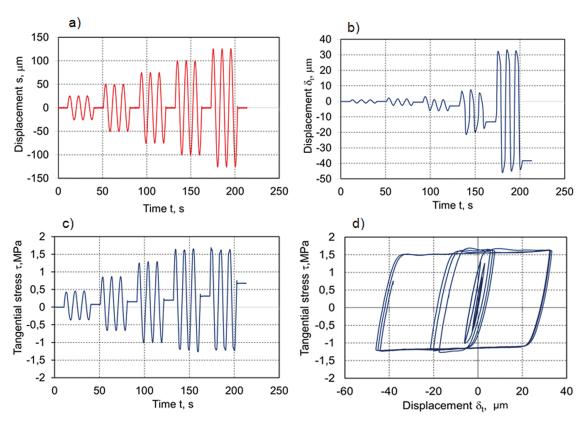
Fig. 8. Results of Experiment 3: a) time evolution of the assumed displacements s(t) performed by the head of the testing machine; b) time evolution of the relative displacements  $\delta_{i}(t)$  of the connected elements; c) time evolution of the average shear stresses acting on the chock; and d) relationships between the stresses  $\tau$  and displacements  $\delta_{i}$

In experiment 3, the tested joint was loaded cyclically, with controlled displacements s(t) of the head of the testing machine. The results of this experiment are shown in Fig. 8.

Figure 8a shows the given displacement program s(t) (sinusoidal vibrations with amplitudes of 25, 50, 75, 100 and 125  $\mu$ m) performed by the head of the testing machine. Figure 8b shows the time evolution of the relative displacements  $\delta_t$ (t) of the connected elements (measured at points 1 and 2), and Fig. 8c shows the time evolution of the average shear stresses acting on the chock for the given kinematic excitations (shown in Fig. 8a). Figure 8d shows the relationships between the stresses  $\tau$  and displacements  $\delta_t$  and the hysteresis loops for the oscillation amplitudes shown in Fig. 8a.

The measurement results show (Fig. 8) that the tested system behaves in a linear elastic manner only at very small amplitudes of vibrations excited kinematically by the head of the machine (up to 0.05 mm). The system behaves nonlinearly at higher amplitudes of vibration. In such cases, complicated nonlinear relationships arise between the given harmonic excitation s(t) and the response of the system. Significant micro-slipping occurs at the contact between the mating surfaces, which in conjunction with the friction forces form large hysteresis loops. Tangential forces carry out much of the work, and this in turn can cause high wearing of the interacting surfaces, and the quick loosening and destruction of this type of bolted joint.
