Monitoring of underdeck corrosion by using acoustic emission method

Krzysztof Emilianowicz, M. Sc.,
Gdańsk University of Technology, Poland

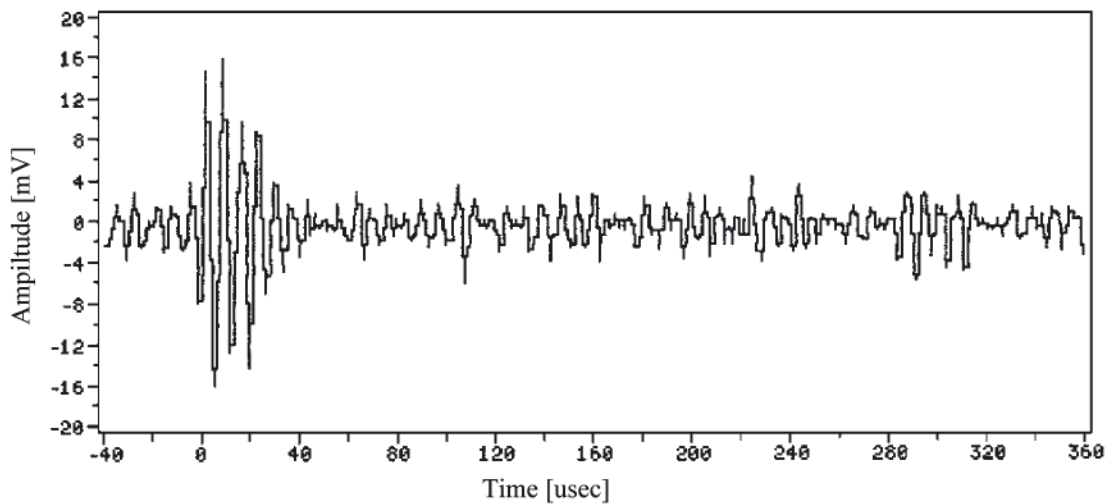
Fig. 2. Run of short wave [4]

Acoustic emission is formed by sound signals which accompany changes of material structure during violent release of internal energy stored in it. During transferring wave through material, in the case of its coming across a defect, dispersion and reflection of the wave occurs. The phenomenon is called acoustic event. During such event, occurs acoustic wave emission which results from released internal energy. The so

formed wave (Fig. 2) is recorded by an acoustic sensor. Events which become sources of wave emission can be of a low-energy or high-energy character [14,4].

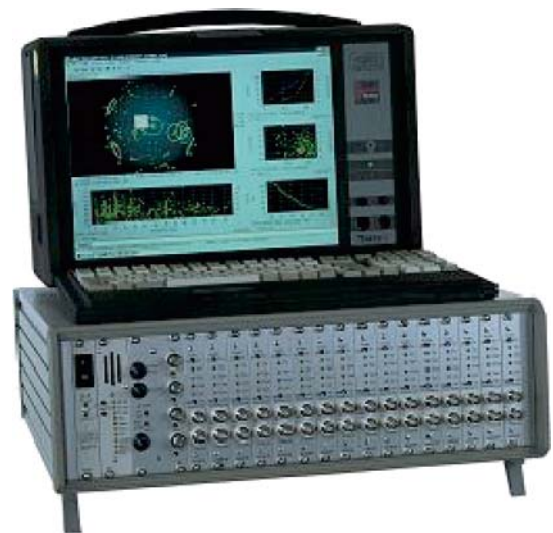
Fig. 6. AMSY-5 system of Vallen Systeme GmbH for AE testing [2]

For recording AE signals and their analysis a specialty software of Vallen Systeme GmbH was used, namely:

- Visual AE,
- Visual TR,
- Visual Class.

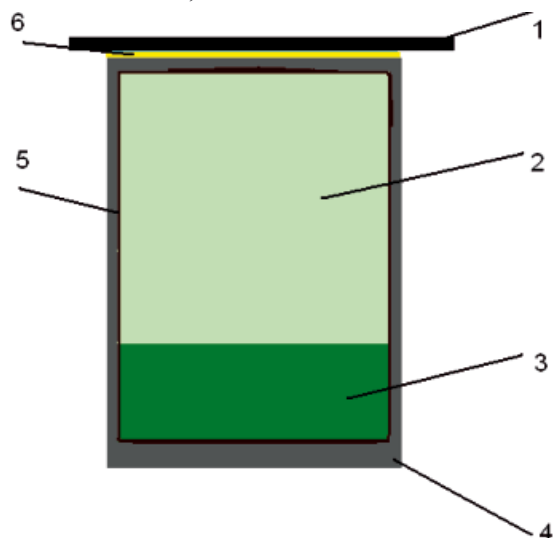
Fig. 8. Schematic diagram of corrosion tester: 1) ship's deck; 2) corrosive gas; 3) corrosive solution; 4) tester's reaction cylinder; 5) initiated corrosion; 6) acoustic contact

Tester is to be built in such a way as to simulate most credibly conditions existing in a given place under testing, hence, the following items are to be appropriately selected:

- a) size of the tester;
- b) material for the tester, which should be the same or close to that to be tested;

- c) surface area of contact of the tester with the tested surface, which should be sufficiently large as to correctly transfer acoustic signal, that is equivalent to tester's detectability;
- d) corrosive solution.

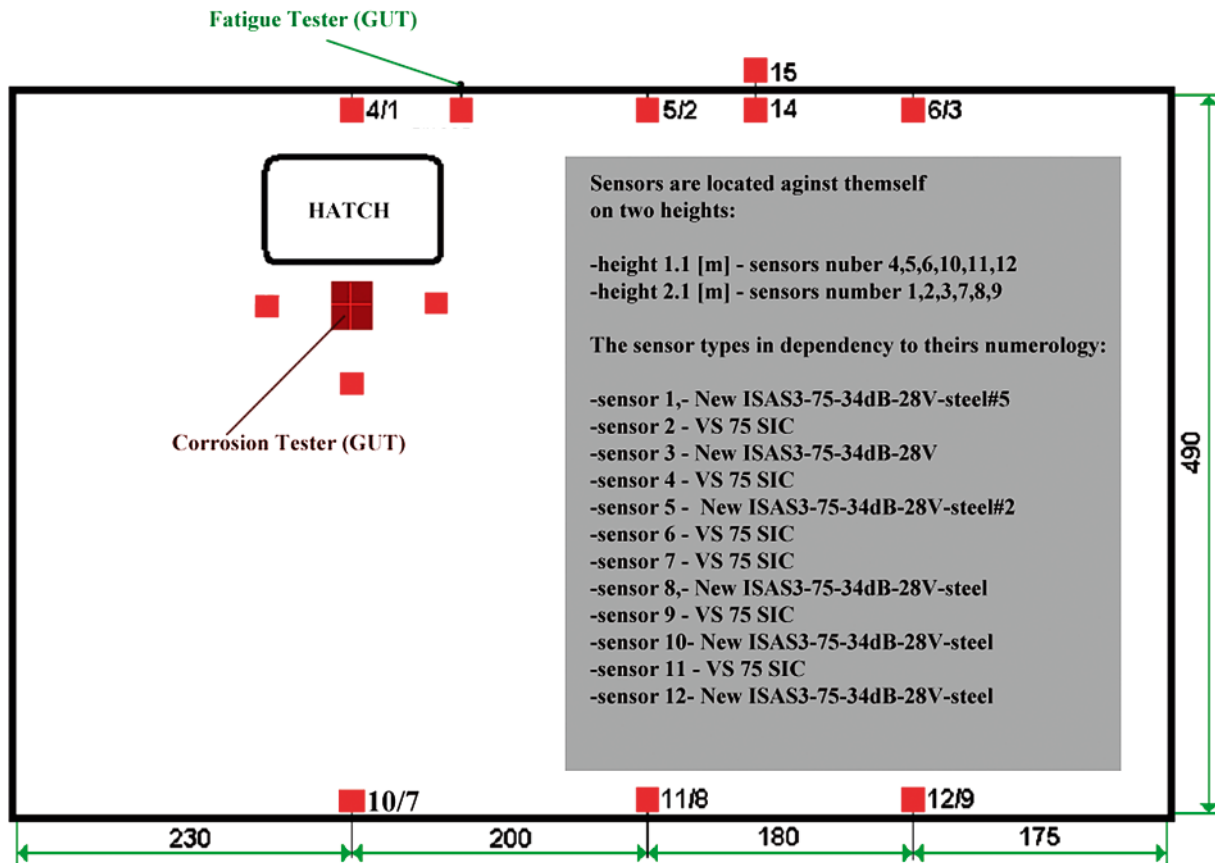
TOP VIEW ON THE TANK NO. 11

Fig. 11. Schematic diagram of arrangement of sensors and corrosion testers inside the tank No. 11 of the Naval Shipyard Co floating dock

The corrosion tester was placed overhead on tanktop internal surface, about 100 mm from a manhole; additional AE sensors (measuring signal coming directly from the GUT

tester) were located on external surface, about 300 mm from corrosion source, directly over the tester.

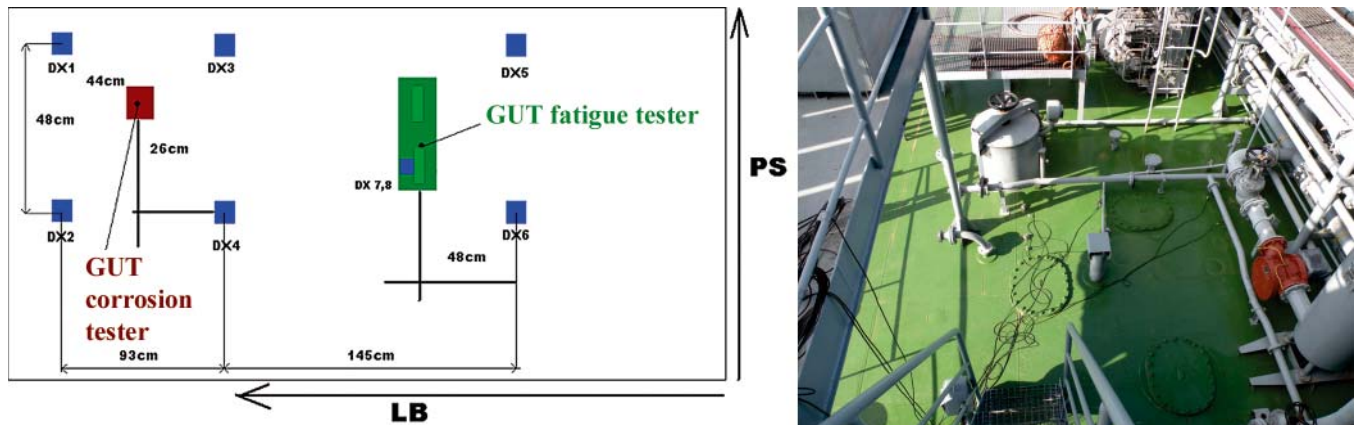
Fig. 14. Location of the test site (the tank No. V12 of cofferdam) and arrangement plan of the sensors on the deck of the Polish Navy tanker „Bałtyk”

The next place of the tests was the tank V12 of cofferdam on the Polish Navy tanker „Bałtyk”. On the contrary to the earlier tests it was not allowed to locally remove paint coating, that was however taken into account during measurements. Also, no data on paint coating thickness were available because it was impossible to get access to painting documentation of the ship. Thickness of the plate was equal to about 6 mm.

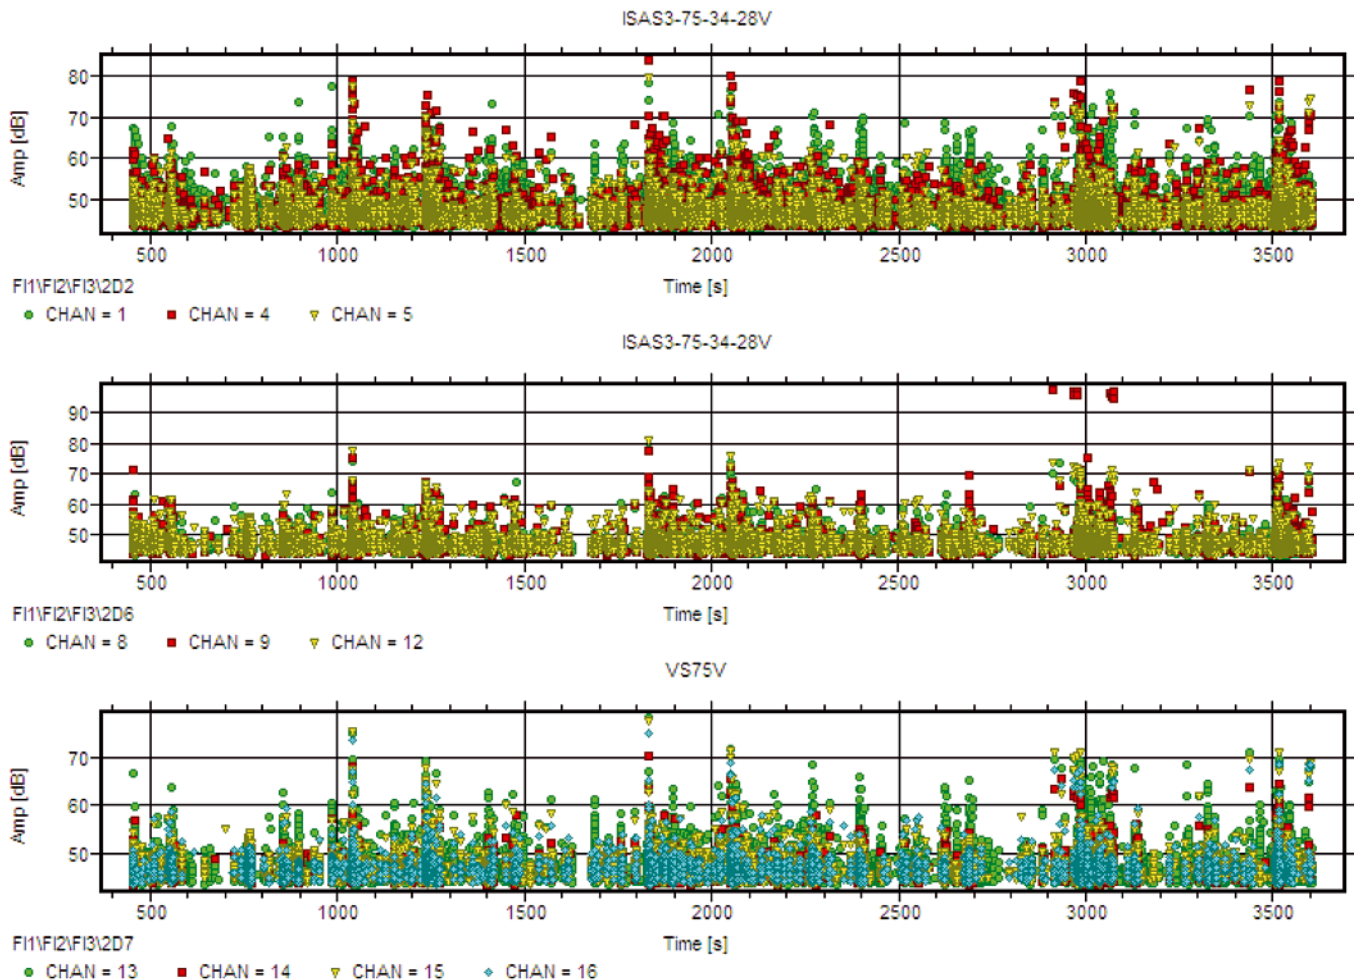
Fig. 15. Standstill test; records of external noise - AE signal amplitude for all measurement signals. $T_h = 43$ dB

- During ship's laying at anchor, at minimum number of ship's systems under operation, when the signal coming from the corrosion tester was so strong that it was possible to locate it. Results for the first testing conditions are presented in Fig. 15 and 16.
- During sea voyage with the ship's systems under operation (main engines etc), when the signal coming from the corrosion tester, however weaker, was possible to be located due to application of a set of filters, e.g. frequency ones. Results for the second testing conditions are presented in Fig. 17 and 18.

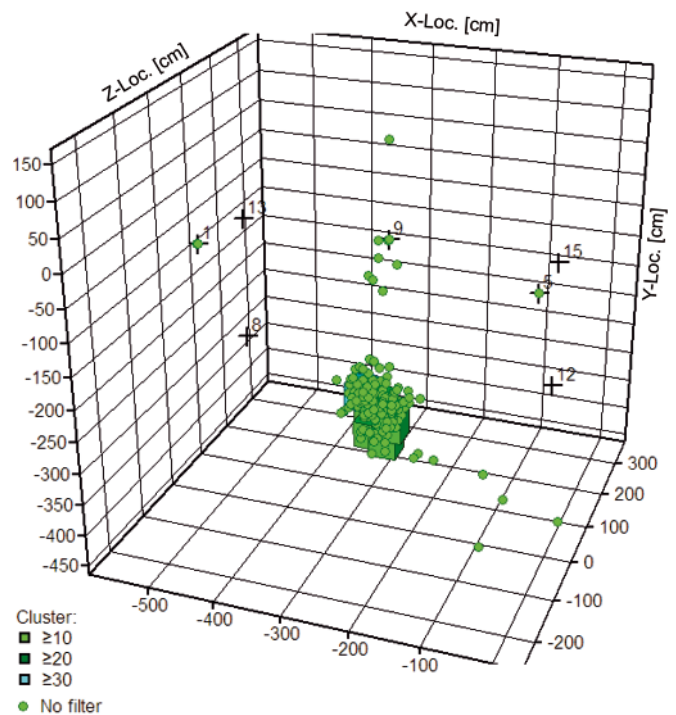
Fig. 16. Standstill test; 3-D location of corrosion source (the tester) close to DX4sensor. $Th = 43$ dB

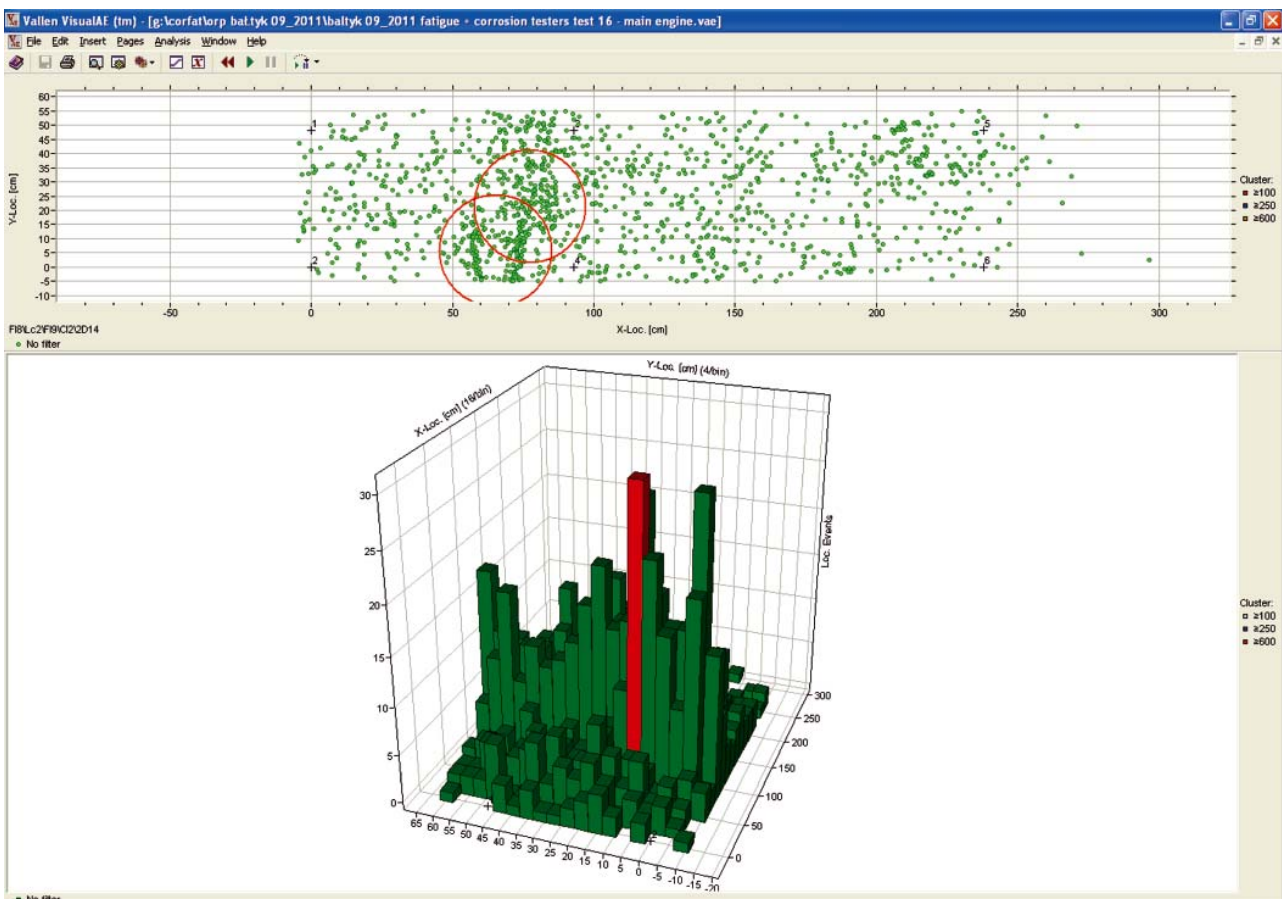
Fig. 17. Location of the corrosion tester and partial location of the tester during operation of engines

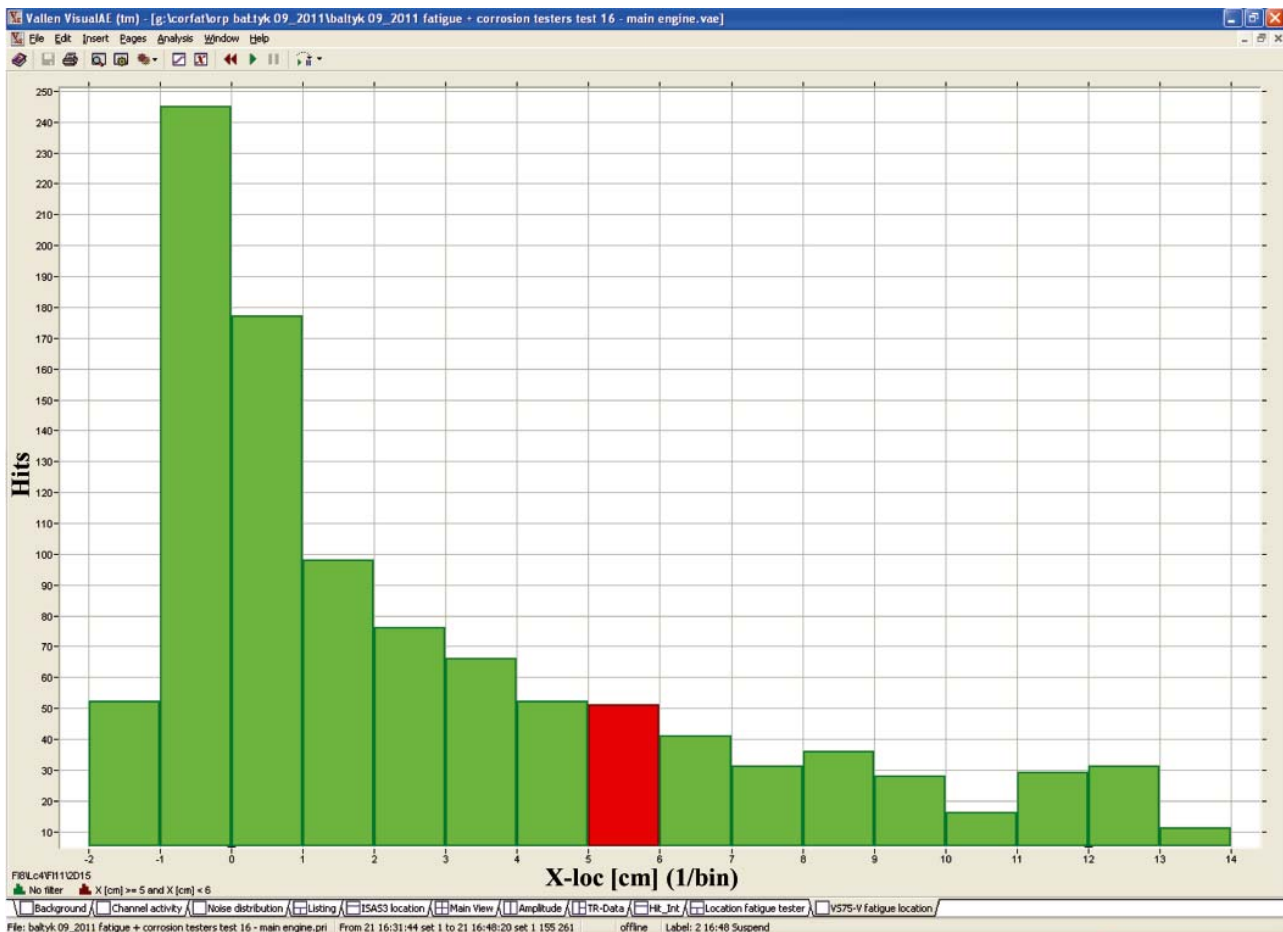
Fig. 18. Diagram of output from ISAS3 sensor - signal coming from the corrosion tester during operation of engines
